Bitterroot Conservation District

Bitterroot River Irrigation Management Study

December 2022

**Bitterroot Conservation District
Bitterroot River Irrigation Management Study**

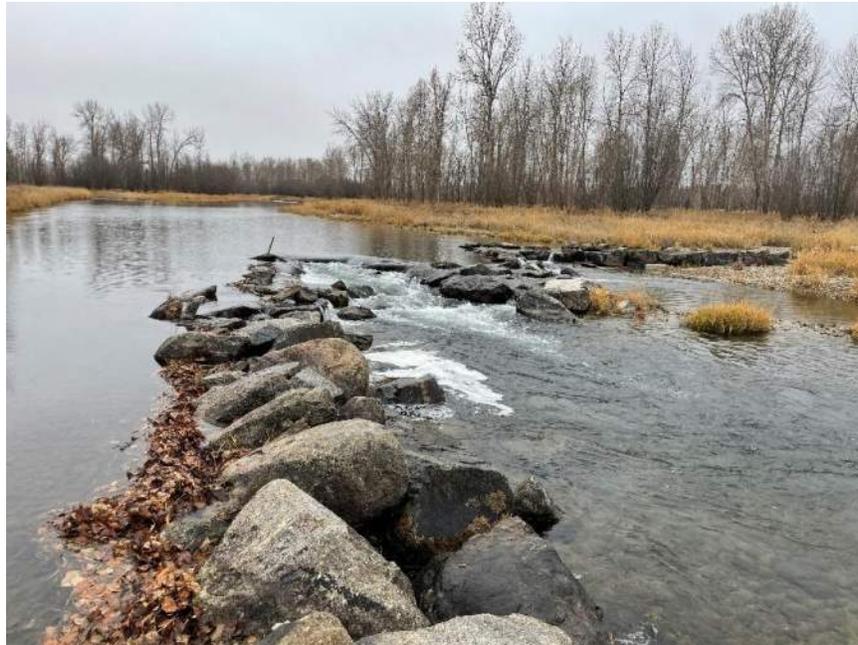
Figure 5: Bill Strange Diversion

The Bill Strange Diversion consists of a w-weir on the East Channel of the Bitterroot built of large rocks, approximately four feet in diameter. There is only one irrigator served by the Bill Strange system and they reported these rocks settling about 2-3 feet over the lifetime of the structure, which is estimated to be nearing 25 years. The diversion works well and provides adequate flow to the ditch.

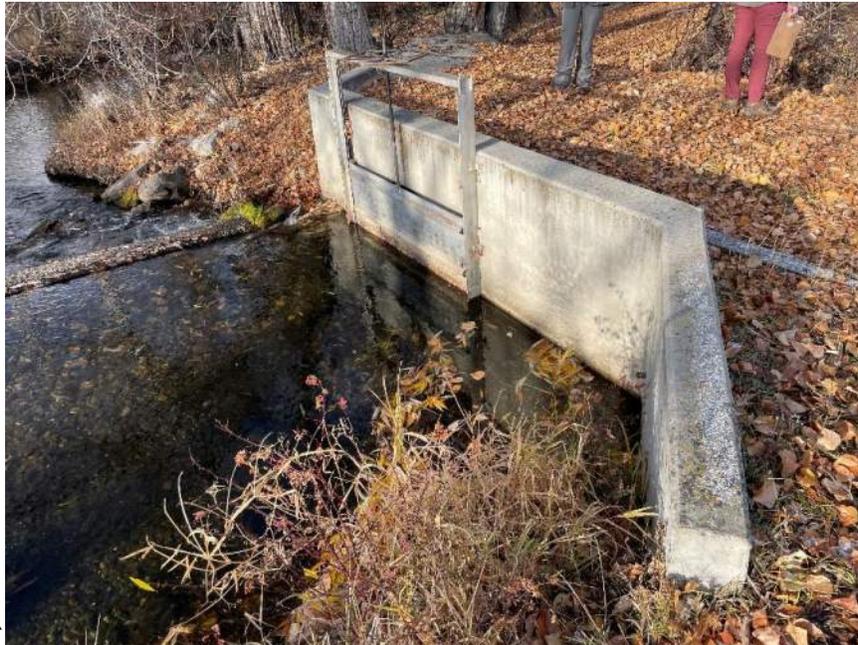
Figure 6: C&C Headgate

Headgate – Good Condition

The C&C headgate structure utilizes a single metal slide gate with a handwheel that opens to a 48-inch squash culvert. Operators of the site reported that the gate lifts a maximum of 3 inches which provides sufficient flow through the ditch throughout the irrigation season. There is also a secondary gate downstream of the ditch that they use to regulate flow. Some overflowing occurs over the headgate during high water events.

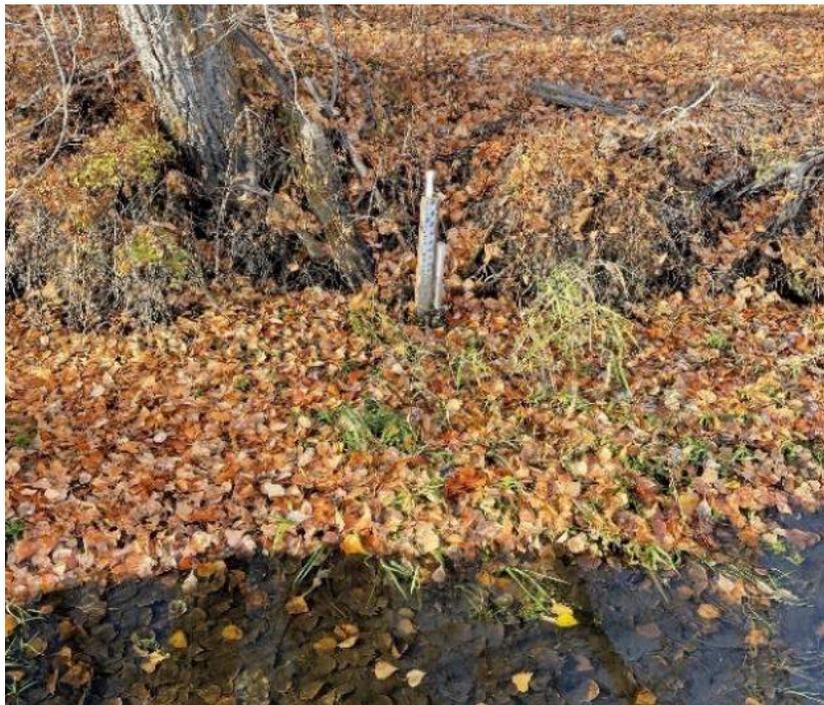
Figure 7: C&C Measurement Gage

Flow Measurement - Poor Condition

There is a staff gage approximately 100 feet downstream of the headgate in the channel. There was notable buildup of vegetation and debris along this section of ditch that would lead to variability in the cross section from year to year and limit the accuracy of any stage-discharge calibration curve.

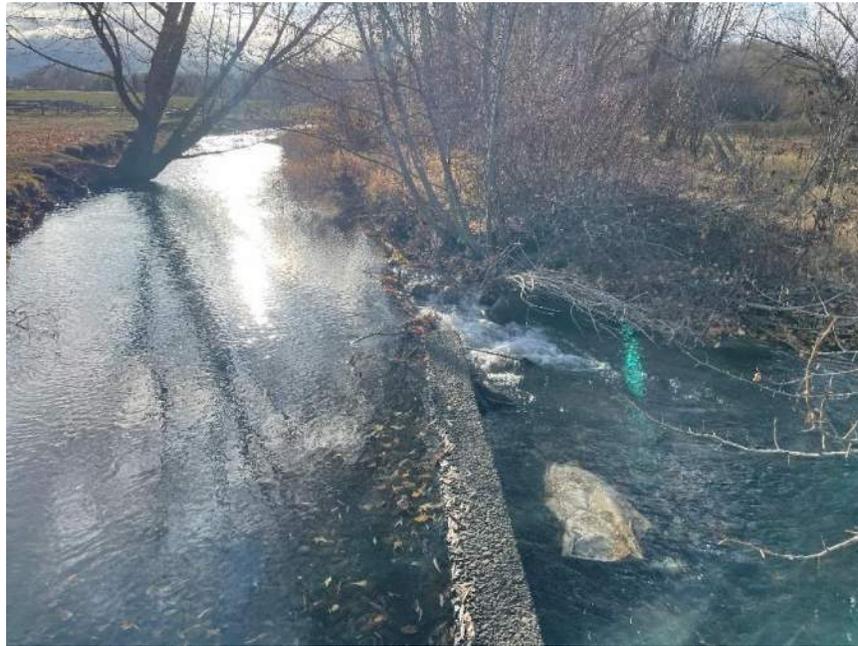
Figure 8: C&C Diversion

Diversion - Fair Condition

The diversion from Skalkaho Creek consists of a 3-foot-tall concrete wall spanning the full width of the creek. The manager reports issues with high water transporting debris and clogging the creek. Areas of the bank at the edges of the wall washed out early in the life of the diversion (several decades ago) but have not eroded further and are currently stable.

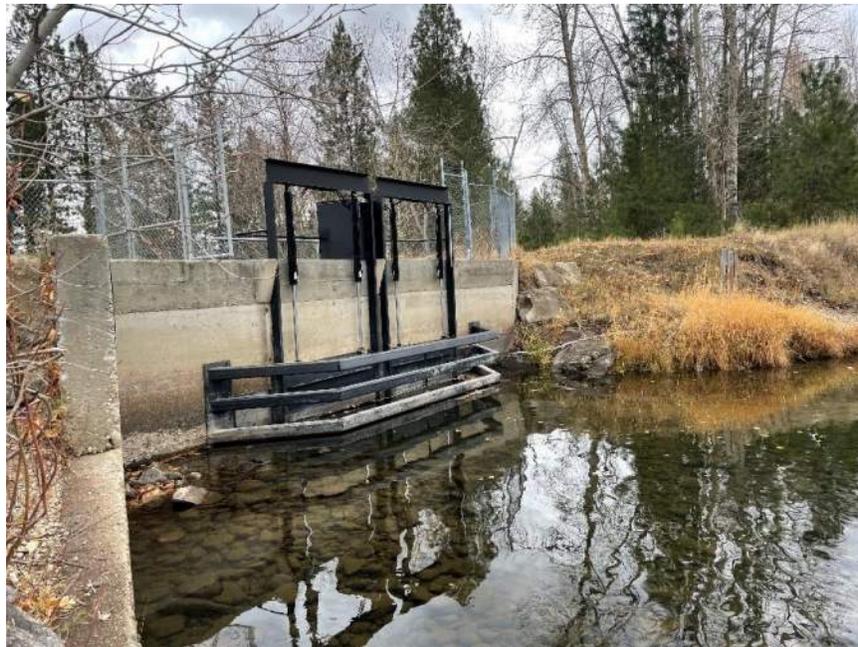
Figure 9: Corvallis Headgate

Headgate - Good Condition

The Corvallis headgate was updated within the past 10 years and is in good condition. The structure utilizes two metal slide gates with electrically powered hydraulic actuators. The concrete headwall and wing wall extending to the north appear to be in good condition. The northern gate is leaking when fully shut due to deterioration of the concrete floor slab which prevents the gate from making a tight seal. The system irrigator that joined the site visit, Darrell Sperry, indicated that the concrete was installed in the 1960's and the floor could be replaced to prevent water from passing through the gates when closed. The structure has a trash rack that collects debris during high water and must be cleaned out. The site is secured with a locked chain-linked fence and signs to prevent trespassing.

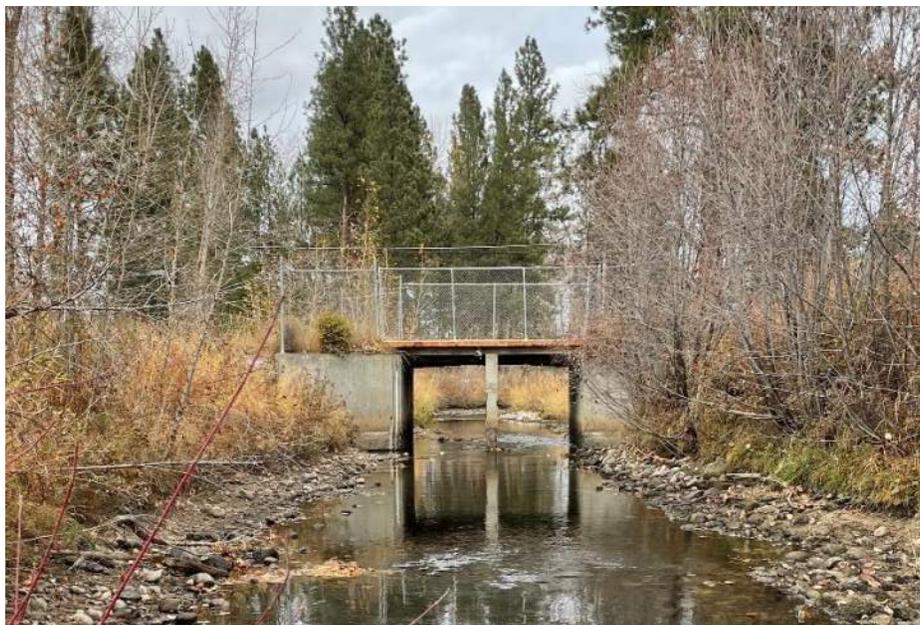
Figure 10: Corvallis Measurement Gage

Flow Measurement – Fair Condition

The primary flow measurement consists of a staff gage with a calibration curve located on a bridge approximately 1,200 feet downgradient of the headgate. This staff gage is enabled with a camera that sends pictures to managers so they can check the water level remotely. There is also a staff gage on the backside of the headgate structure. Because both staff gages are located at locations where flow is not uniform, so accuracy of any calibration curve is questionable.

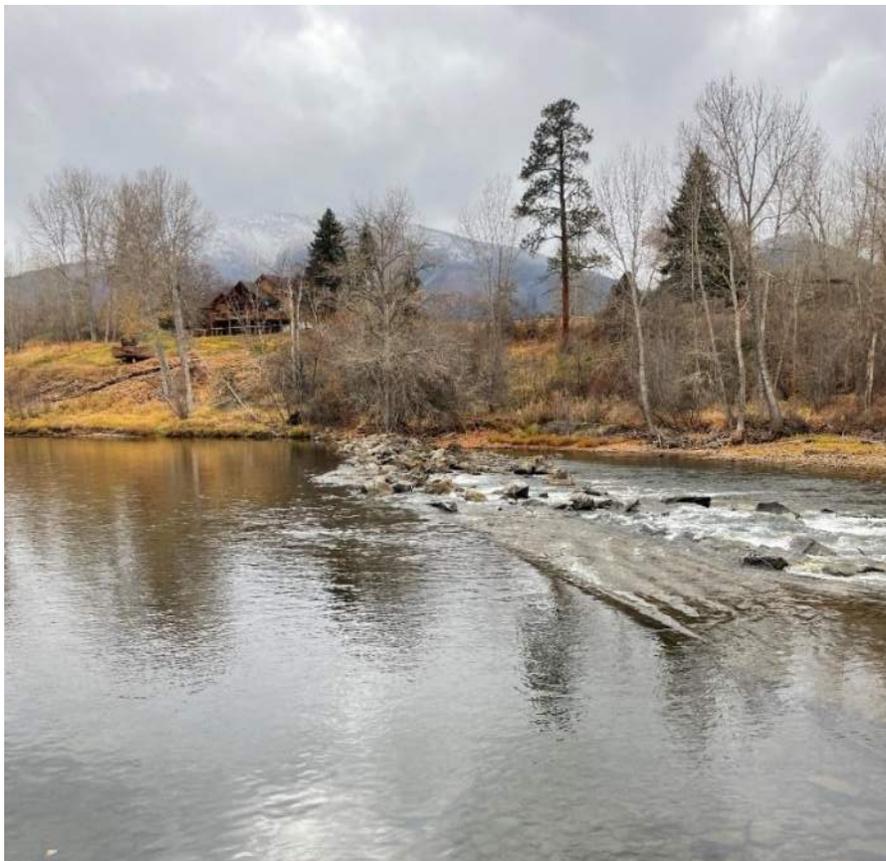
Figure 11: Corvallis Diversion

Diversion - Good Condition

There is an in-stream rock check on the left side of the river and a concrete slab along the right that divert water from the main Bitterroot River through the Corvallis headgate with good ability to regulate water level. The concrete slab includes recessed locations in which to place steel pipes. Stop logs can then be secured against the pipes to raise the water level as needed throughout the irrigation season. While this system provides for effective and flexible water level regulation, it requires operators work within the channel to place the diversion throughout the season, which presents a safety hazard. Additionally, the pipe recesses in the slab can gather sediment, requiring cleaning before the pipes and stop logs can be placed. The operator of the site reported that the large rocks (approximately 3-4 feet in diameter) that constitute the rock check occasionally wash downstream and equipment is required to move the rocks back to the front of the dam every 2 to 3 years.

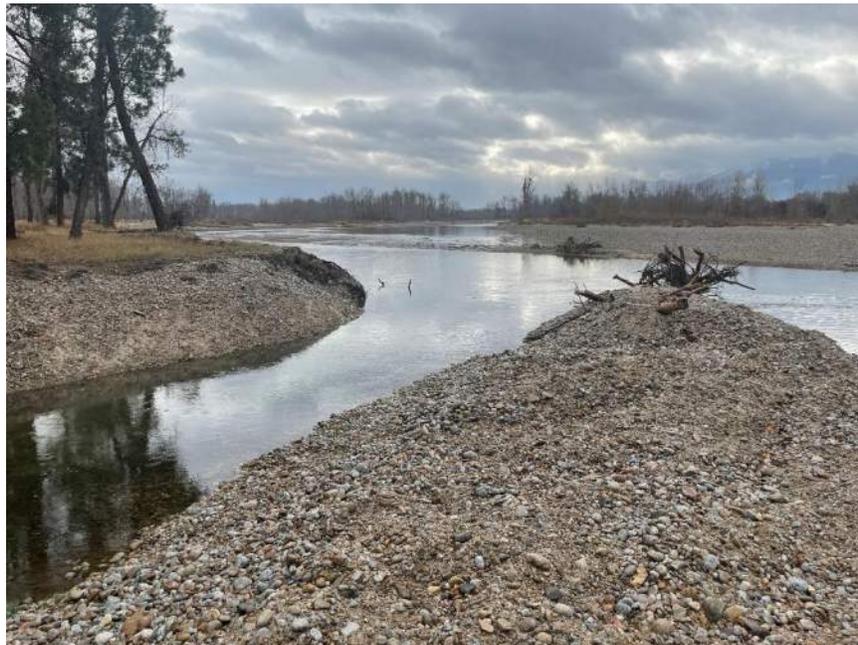
Figure 12: East Channel Diversion

Diversion – Poor Condition

During low flow in the Bitterroot River, particularly late in the irrigation season, maintaining sufficient flows in the East Channel is challenging. The current strategy, as reflected in the Etna, Union, and Webfoot Ditch Company’s 310 permit, is to build a temporary check structure of native cobbles and gravel on the east side of the main channel. While early season high flows are typically sufficient for irrigation needs, these flows contribute to sedimentation in the East Channel that creates challenges for maintaining sufficient flows in the late season.

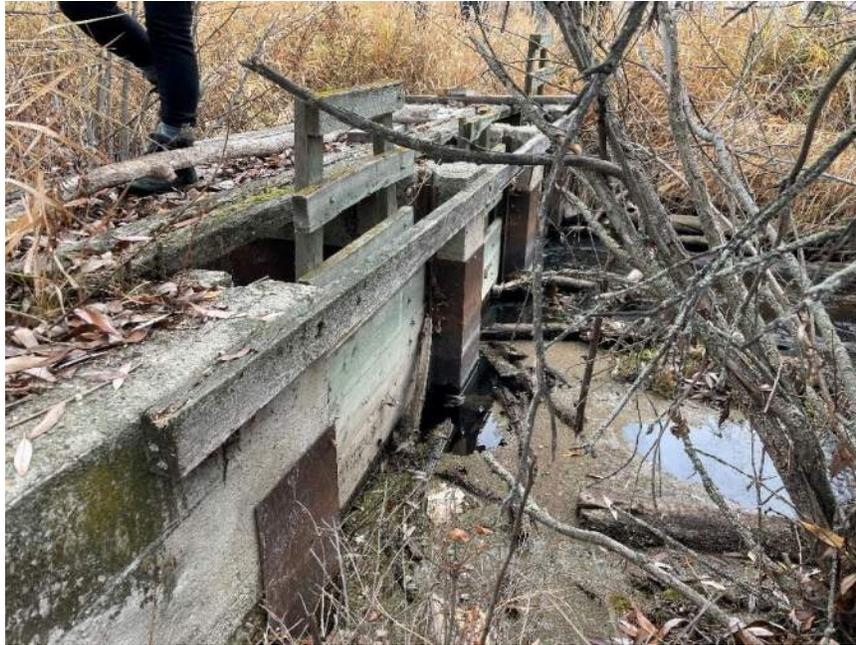
Figure 13: Etna Headgate

Headgate - Poor Condition

and require maintenance to prevent blockage at the inlet. The walkway is comprised of wood boards that are weathered and could be replaced. Installing a handrail would improve safety at the headgate.

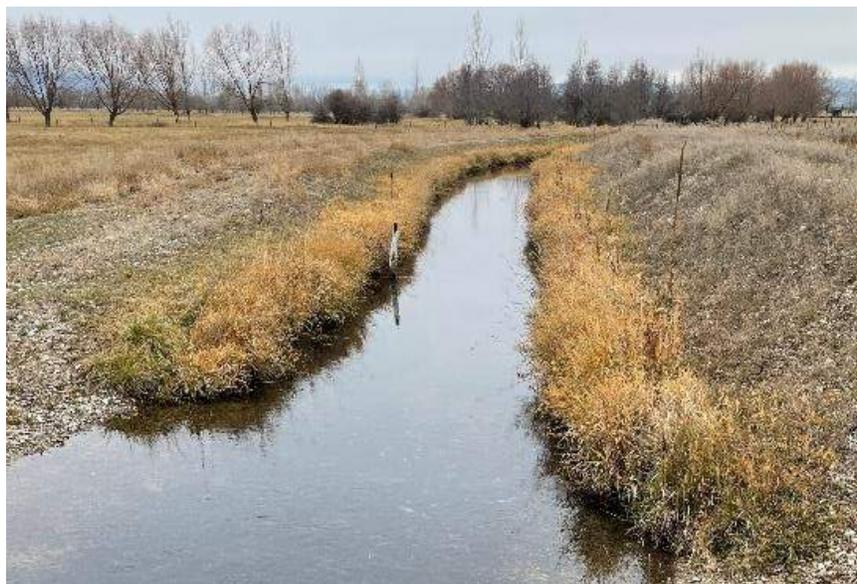
Figure 14: Etna Measurement Gage in Channel

Flow measurement consists of a staff gage approximately 50 feet downstream of the headgate structure in a natural-bottom channel with irregular cross section. Because of the potential variability in the cross section from year to year due to sedimentation, erosion, and vegetation, the accuracy of any calibration curve is questionable.

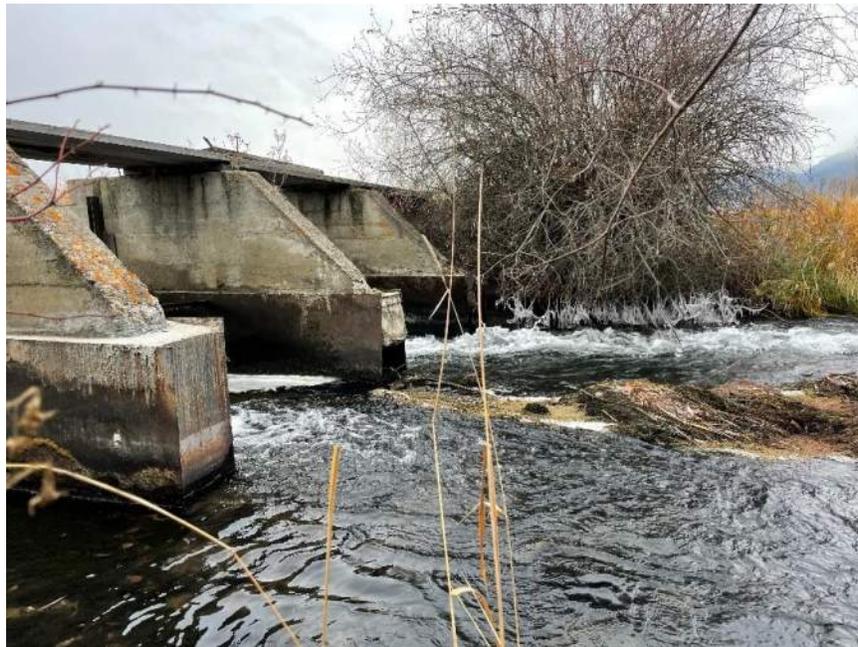
Figure 15: Etna Diversion

The Etna diversion from Mitchell Slough is a concrete check-dam with wooden stop logs. The dam has four concrete gate openings and stop logs are installed manually by hand in the spring and pulled out in the winter. Once the logs are in place there are no further flow adjustments that can be made, as it becomes very difficult to move them with the pressure of flow against them. Several of the concrete walls that separate the gate openings are failing on the downstream side, with significant loss of concrete at the bottom of the downstream end of several of the walls. The middle walls are missing up to 12 to 24 inches of concrete but have been augmented with steel plates grouted to either side of the wall, as shown in Figure . There is also some evidence of erosion of the embankment on the downstream right side of the structure. Given the ongoing failure of concrete at the structure and potential for further erosion, the structure is unstable and should be replaced. Wood boards are laid across the top of the check dam to allow crossing and there is no handrail, which creates a safety hazard.

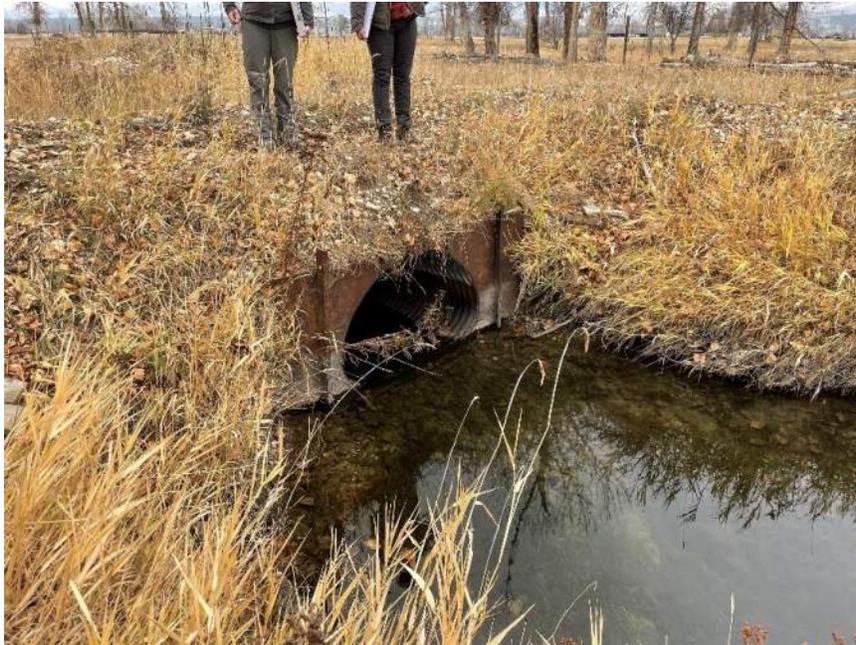
Figure 17: Gerlinger Headgate Inlet

The Gerlinger headgate is a corrugated steel squash culvert that utilizes wood stop logs to manage flow. The stop logs are inserted into metal channels that are welded to the face of a metal headwall. The wood planks are manually installed and removed by hand each year. The manager at the site claims this system works well.

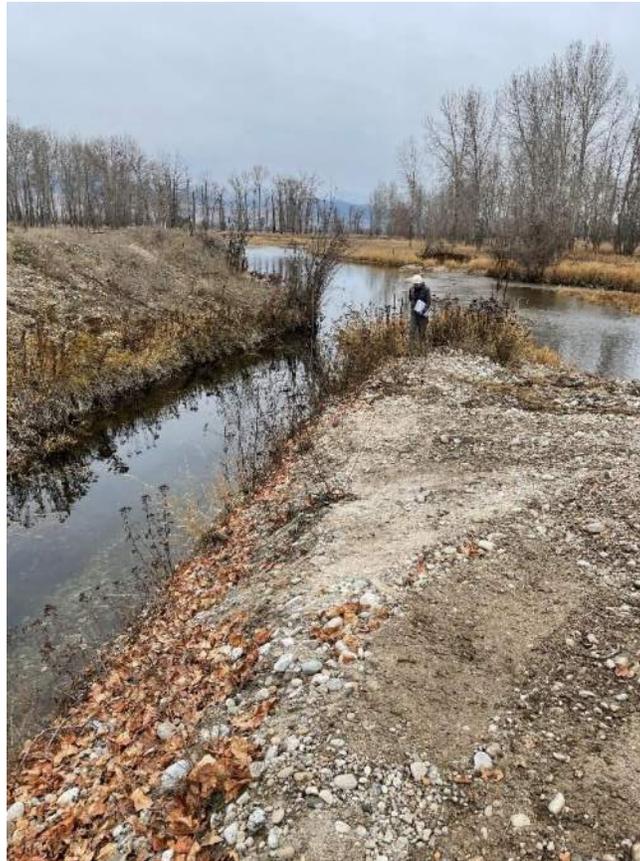
Figure 18: Gerlinger Diversion

Concrete eco-blocks are installed and removed in the East Channel of the Bitterroot each year, using an excavator, to ensure flow through the headgate. A total of 28 eco-blocks are stored at the site. The eco-blocks extend off a rock point bar into the East Channel.

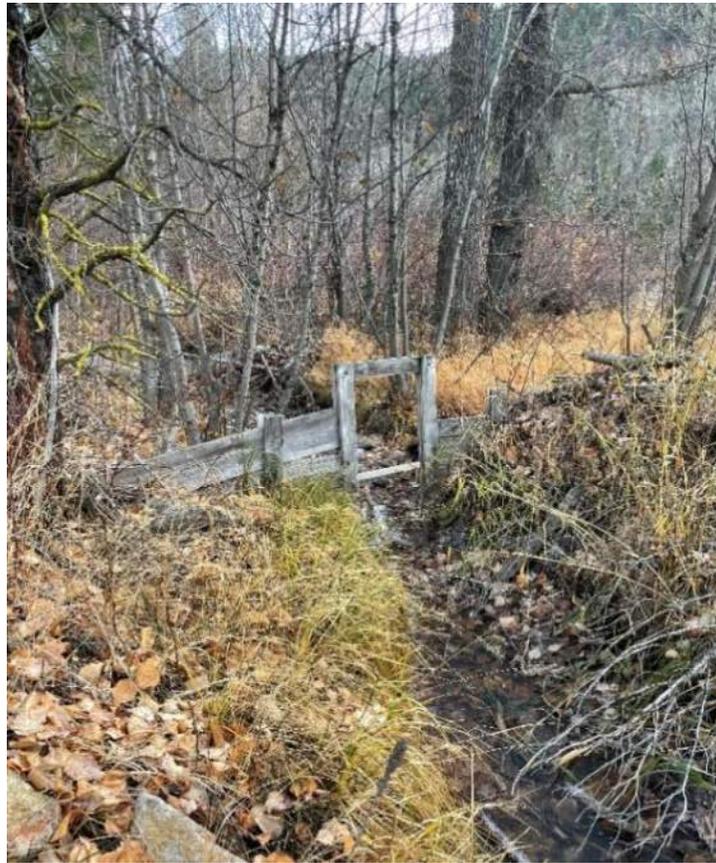
Figure 19: Hoyt Headgate Structure

There is a wooden structure serving as the Hoyt headgate that appears to have no currently functioning mechanism for control. The wood is rotting, warped, and will need to be replaced. There is a significant amount of debris and vegetation built up at the headgate and will require maintenance to prevent blockage at the inlet.

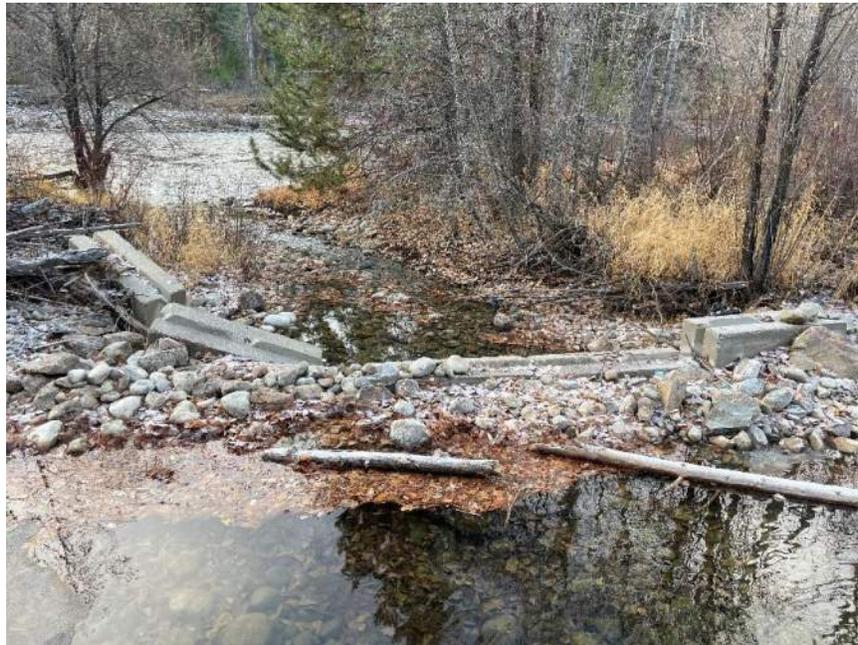
Figure 20: Hoyt Diversion

There is a 2-foot concrete check and twelve eco-blocks, stacked two high and six across, diverting water from the Orr/Hoyt channel into the Hoyt headgate. There is an additional check structure to divert water into the Hoyt headgate. There is a significant amount of debris and large boulders upstream of the Hoyt check structure. This headgate is sensitive to water releases from Painted Rocks Reservoir due to measurable changes in water elevation against the headgate. This requires coordination of gate adjustments with changes in releases from the reservoir since the ditch has not purchased Painted Rocks water.

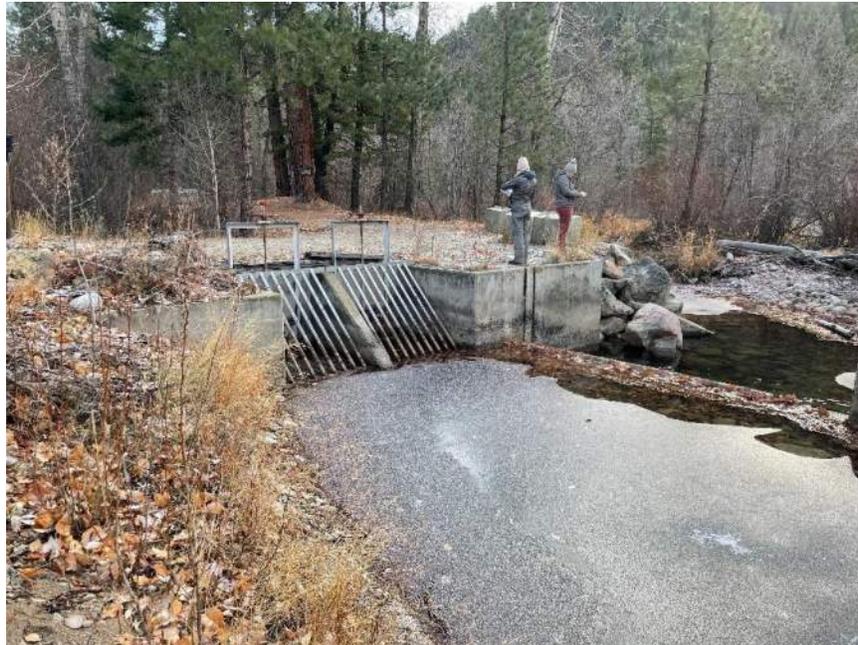
Figure 21: Orr Headgate

Orr headgate is a concrete structure with two handwheel-actuated, metal slide gates that open to two 35 x 24-inch corrugated pipe arches. The concrete structure, headgates, and actuators appear to all be relatively new and in good condition. The pipes are somewhat rusted, but the corrosion appears to have only affected the surface and the pipes do not display degradation of their structural integrity. The slide gates were completely shut and, while there was ponded water on both sides of the gates, there was no flow, indicating there is minimal to no leakage of gates. There was some sediment deposited in the culverts. There is an angled trash rack constructed of round metal bars in front of the slide gates.

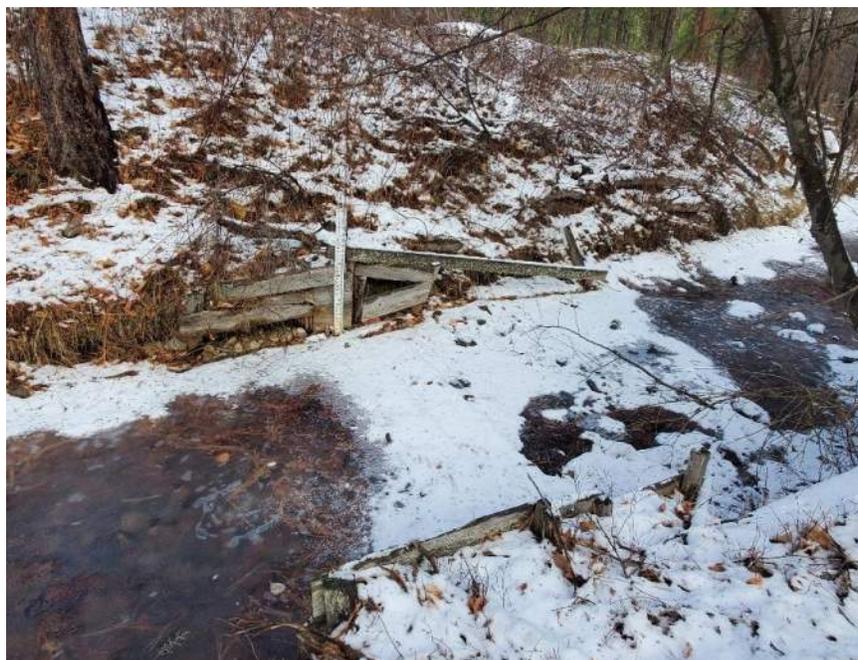
Figure 22: Orr Measurement Gage

The measurement gage for the Orr system consists of a staff gage in a wooden flume within a few hundred feet of the headgate.

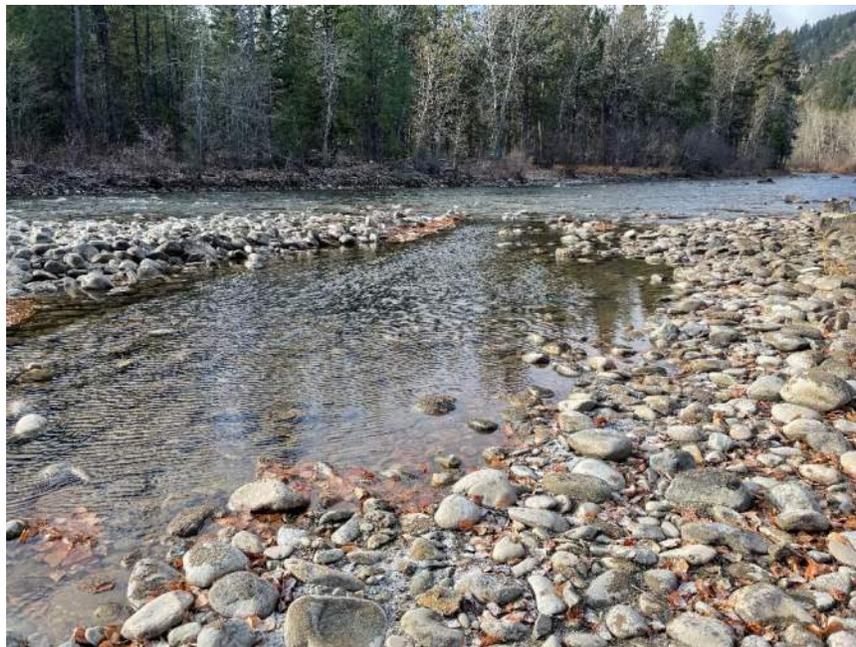
Figure 23: Orr/Hoyt River Diversion

The first diversion in the Orr/Hoyt system consists of a channel excavated from native materials on the east bank of the West Fork. System operators indicated there were no issues getting sufficient water into this channel through the irrigation season. The channel runs 500-600 feet downstream to the Orr headgate, where there is a concrete check structure that helps control how much of the diverted water enters the Orr headgate versus how much flows past to the Hoyt headgate and back to the river. The check structure consists of a 2-foot concrete wall and twelve eco-blocks, stacked two high and six across, diverting water from the West Fork to the Orr headgate and Hoyt structure. There is a significant amount of debris and large boulders past the diversion on the Hoyt side.

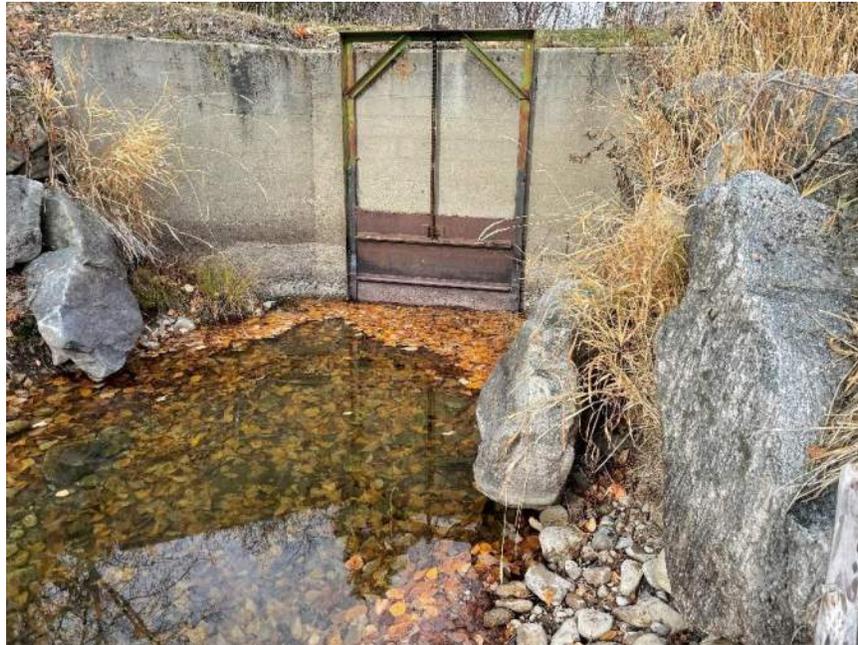
Figure 25: Overturf Headgate

The headgate structure consists of a concrete headwall and wingwalls in good condition with metal slide gate opening to a corrugated steel 58 x 36-inch pipe arch. There is evidence of sediment buildup at the outlet of the culvert. While there is standing water on the ditch side of the headgate, there appeared to be no flow, indicating minimal to no leakage.

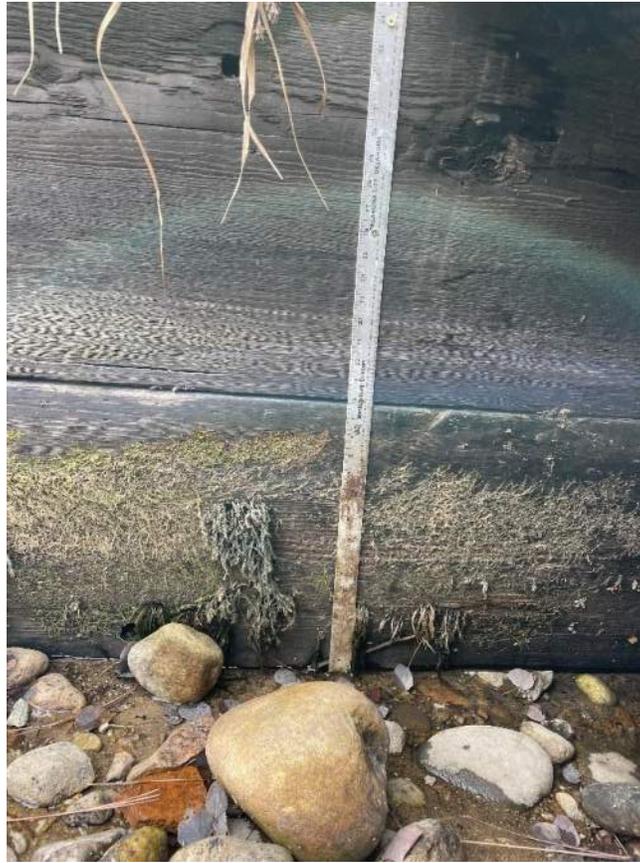
Figure 26: Overturf Measurement Gage

There is a staff gage located at the entrance of wood box culvert a quarter mile downstream of headgate. The box culvert is approximately 3 feet deep, 5 feet wide, and 60 feet long. Because the staff gage is at the entrance of a box culvert and immediately after 90-degree bend to the west, flow is not uniform at the location and the accuracy of any calibration curve is questionable. There is also a handmade measuring device that is PVC pipe with a black line at 14 inches and a red line at 18 inches. If the water level is at or below the 14-inch mark, the last water user does not receive water. If the water level is above the 18-inch mark, portions of the ditch will overtop.

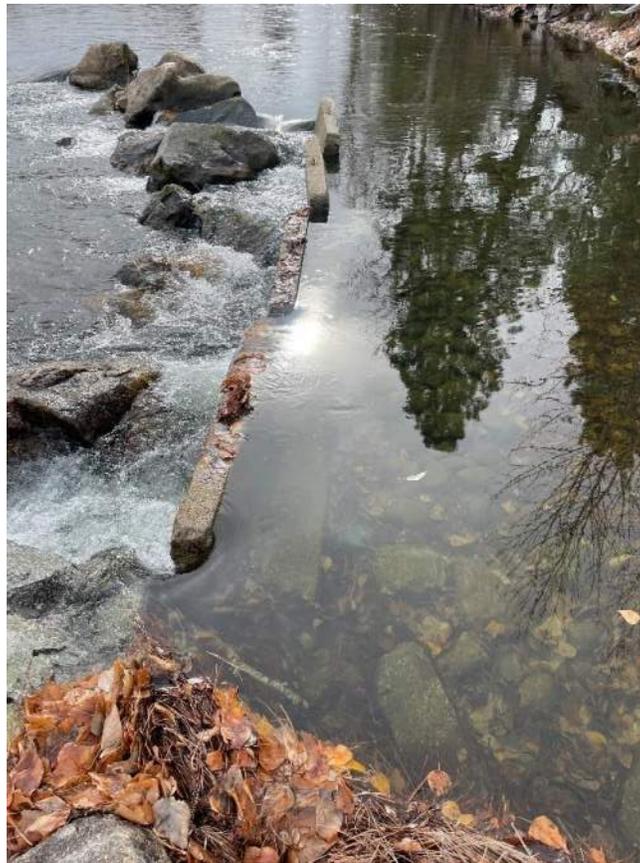
Figure 27: Overturf Diversion

Four concrete dividers are placed each year, extending into the main channel of the Bitterroot River and are reinforced with many large, 4-foot diameter boulders. Getting water to flow into the Overturf ditch is a challenge every year and they have trouble getting water to the irrigator at the end of the ditch.

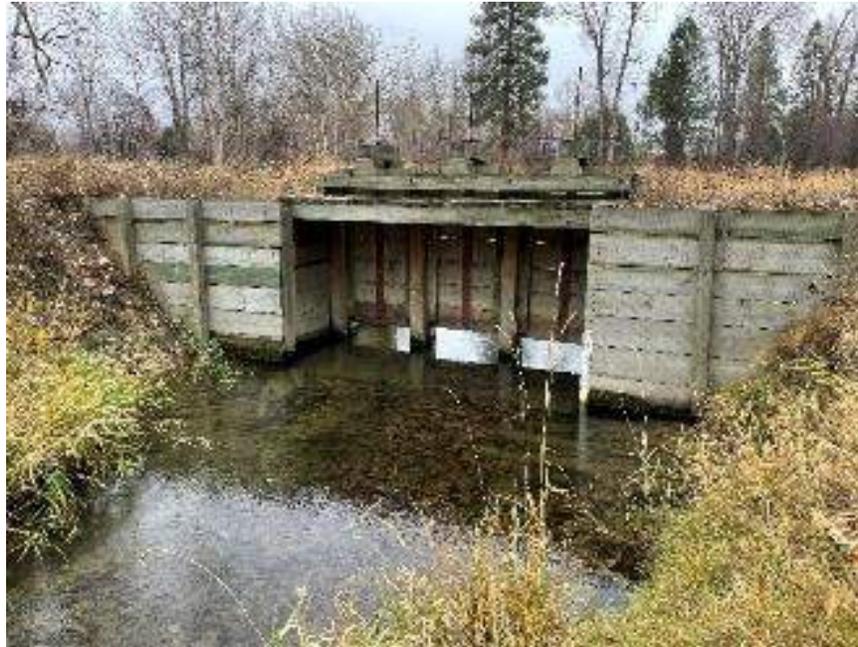
Figure 28: River Ditch Headgate and Staff Gage

The River Ditch headgate is a wood structure that was rebuilt within the past 10 years and remains in good condition. The structure is comprised of three wood slide gates actuated by handwheels. There is a wood walkway across the channel that is in good condition. A handrail could be installed at the headgate to improve safety.

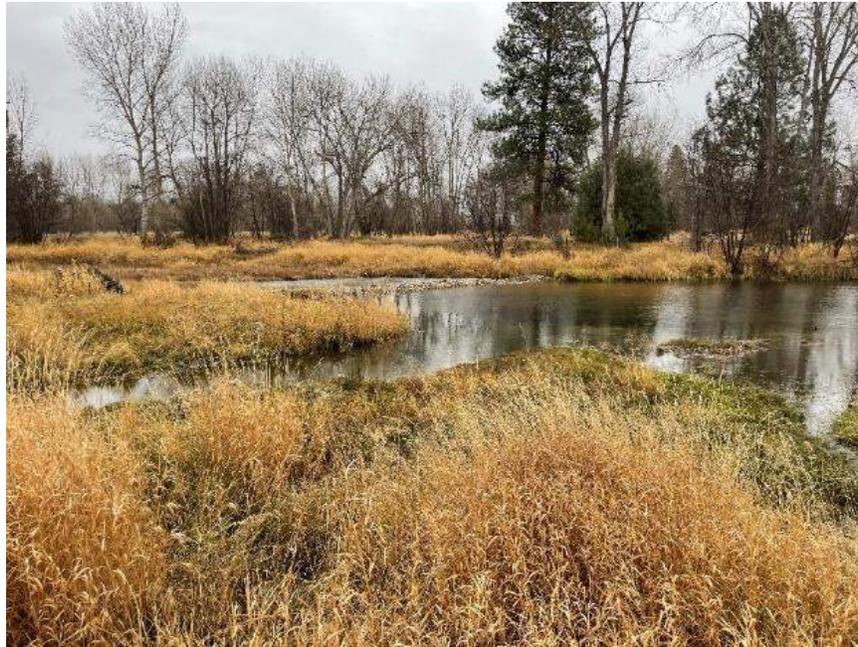
Figure 29: West Channel River Ditch Diversion

The main issue at this location is getting enough water routed via the first diversion into the West Channel from the main Bitterroot River. The manager of the site said that he walks a rubber tire backhoe about a mile up the West Channel each year to rebuild the river rock bar diversion at the Main Channel to ensure adequate flow to the West Channel. A second diversion near the headgate consists of temporary dam that is built across the West Channel of the Bitterroot River with a fish passage cut out. Both diversions are considered to be in fair condition and will be ranked together as one linked system.

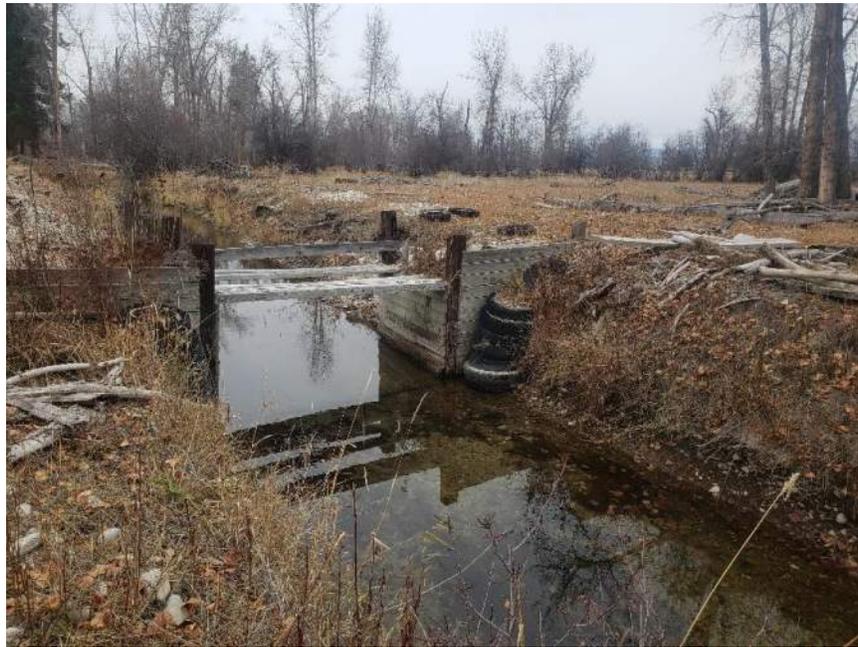
Figure 31: Spooner Headgate

bank that separates the East Channel from the Spooner Ditch has eroded significantly over recent years. If the erosion continues, the head gate structure could be at risk from undermining and failure.

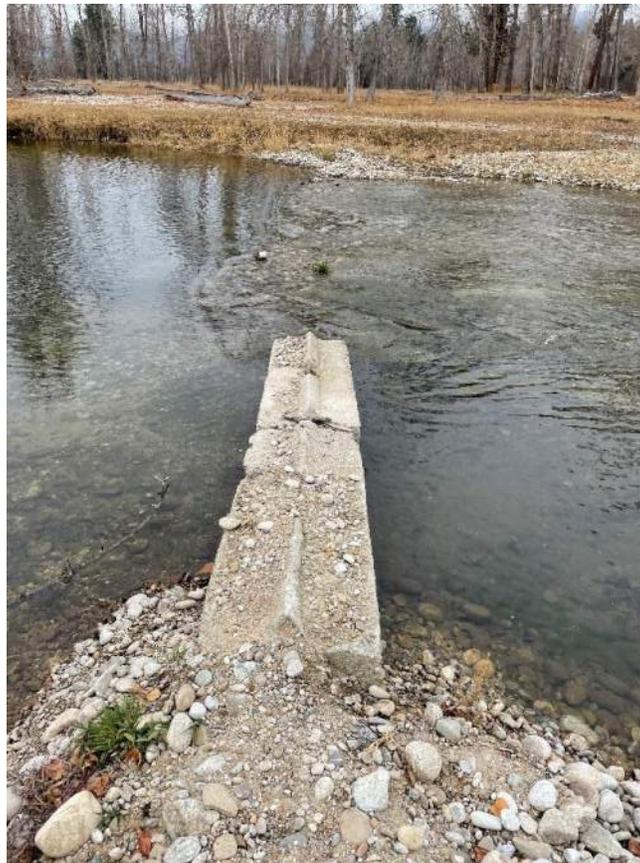
Figure 32: Spooner Diversion

Two concrete eco-blocks, approximately two feet tall and wide by six feet long, are left extending into the East Channel of the Bitterroot River from the east bank throughout the year. Metal stands are placed across East Channel each year with a tractor and then stabilized by burying the downstream base with gravel. Stop logs are then placed in the metal stands to form a temporary check structure to increase the water level as needed throughout the irrigation season.

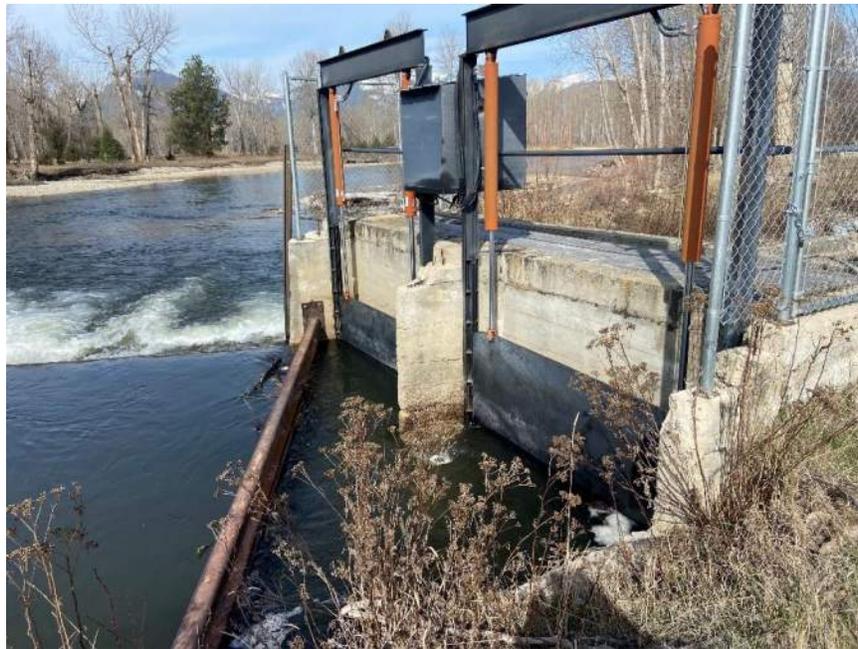
Figure 33: Supply/Woods Parkhurst Headgate

The Woods Parkhurst/Supply headgate is a concrete structure with hydraulically operated metal slide gates. The structure and gates were constructed in 2017. There are no reported issues with the operation of these gates. Operators have stated that they have issues with large sticks and debris getting trapped in and against the trash grate requiring someone to remove debris 5-6 times per year.

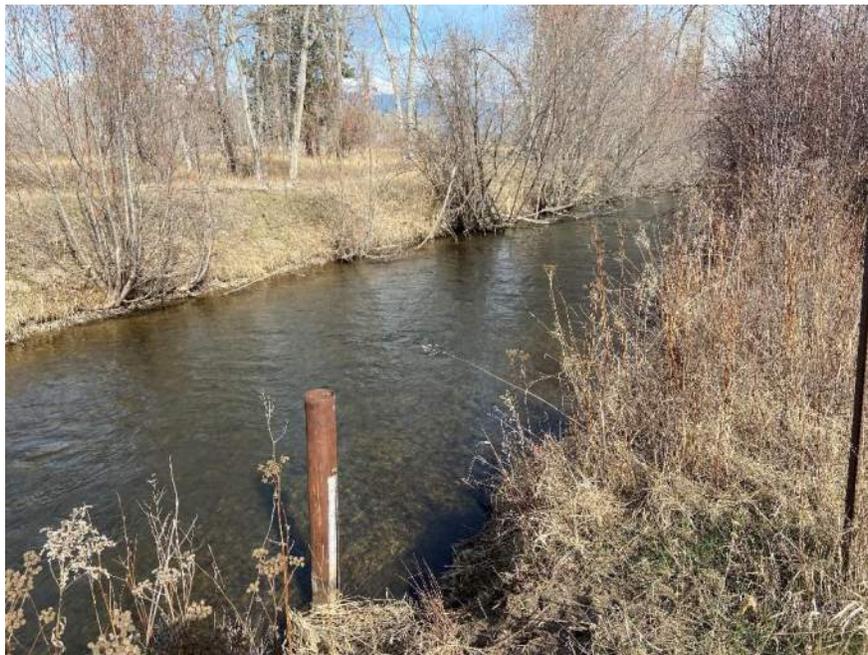
Figure 34: Supply/Woods Parkhurst Measurement Gage

A staff gage is located approximately 100 feet downstream of the headgate in a fairly uniform channel section. The gage is mounted on a steel pipe. There was a small amount of vegetation caught against the gage when viewed during the site visit.

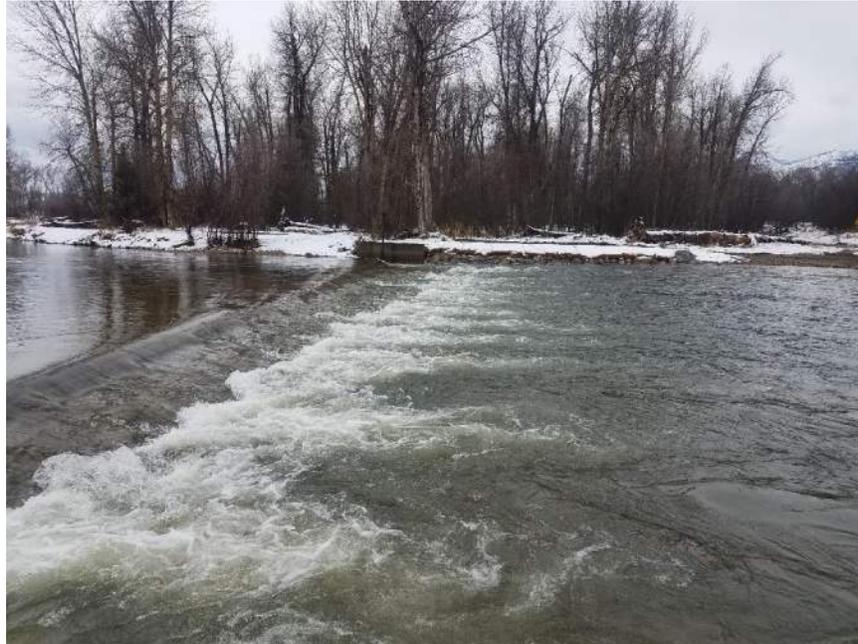
Figure 35: Supply/Woods Parkhurst Diversion

The Woods Parkhurst/Supply Diversion Dam is located on the eastern-most braid of a highly braided section of the Bitterroot River and delivers water to both Supply and Wood-Parkhurst ditches. The dam is in overall good condition and significant structural improvements were made in 2017.

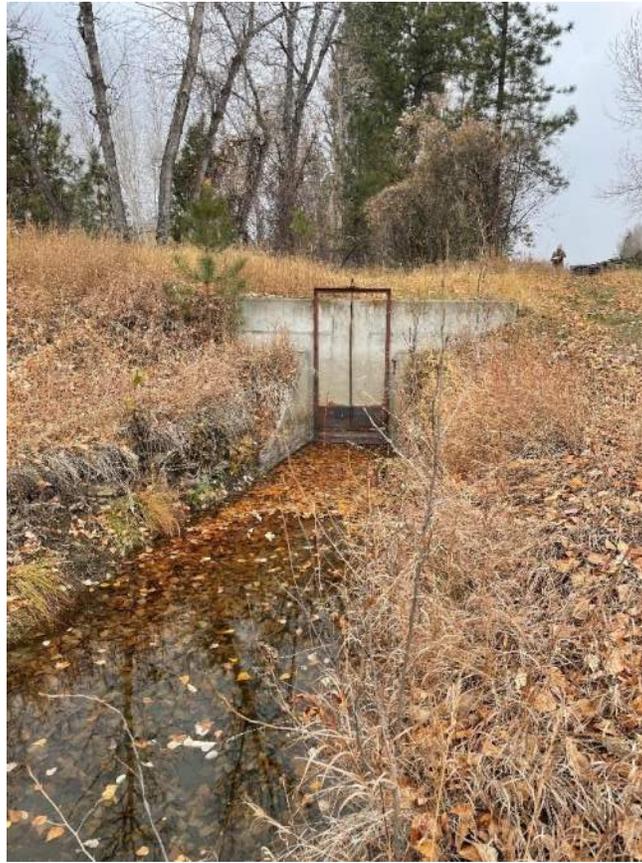
Figure 36: Tiedt-Nicholsen Headgate

The Tiedt-Nicholsen headgate is a concrete structure with a single metal slide gate that is adjusted with a handwheel. The slide gate opens to a 44 x 26-inch corrugated arch pipe. The stem on the handwheel to the slide gate is bent but still works. The manager at the site reported that they get excess water from Bunkhouse and Overturf and don't need to open this headgate until about mid-July.

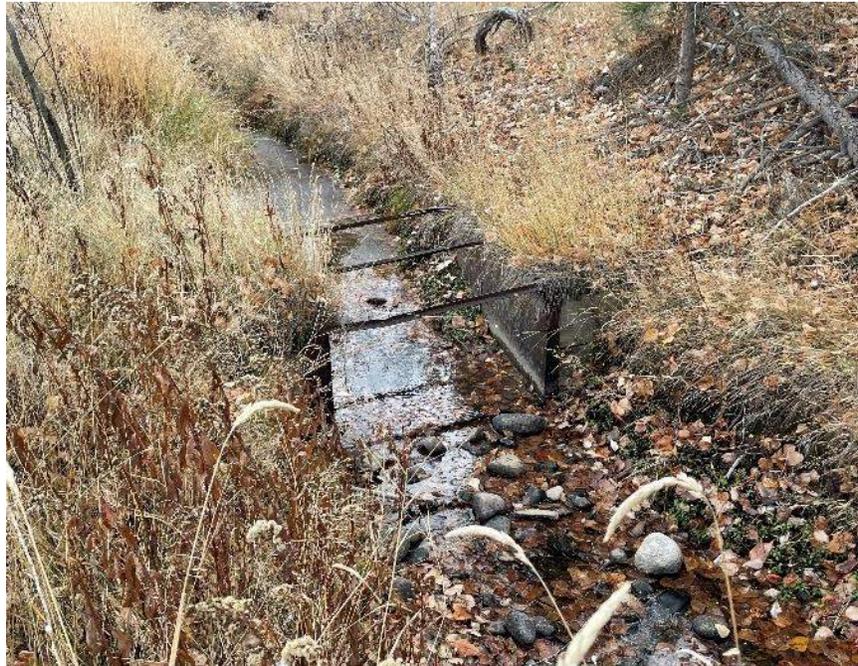
Figure 37: Tiedt-Nicholsen Metal Flume

There is an old steel measurement flume downstream of the headgate.

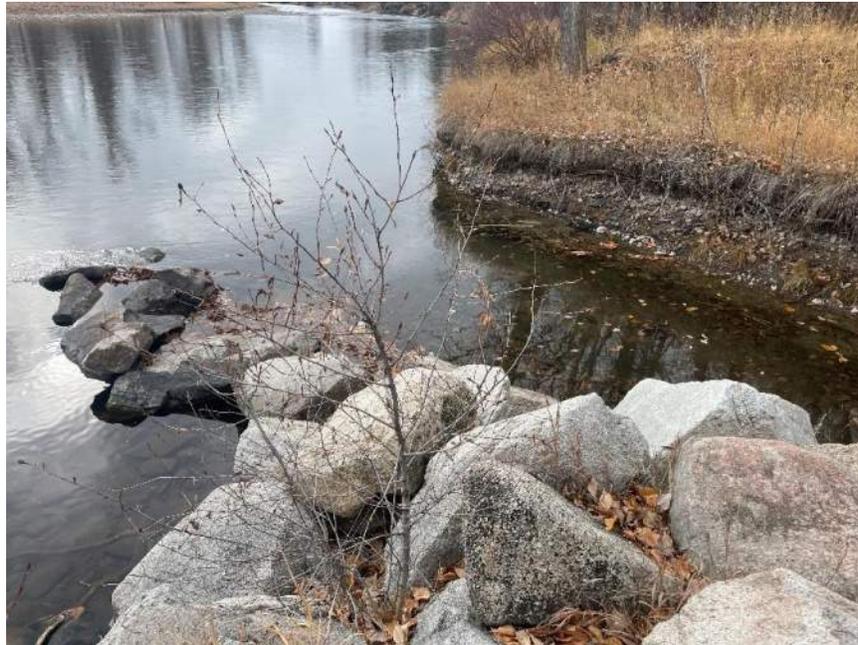
Figure 38: Tiedt-Nicholsen Diversion

Three to four-foot diameter boulders have been placed to form a small jetty that diverts water from the main Bitterroot River channel to the Tiedt-Nicholsen ditch. Operators stated that diverting water from the river is not usually an issue but there are concerns about the main channel of the river migrating to the east.

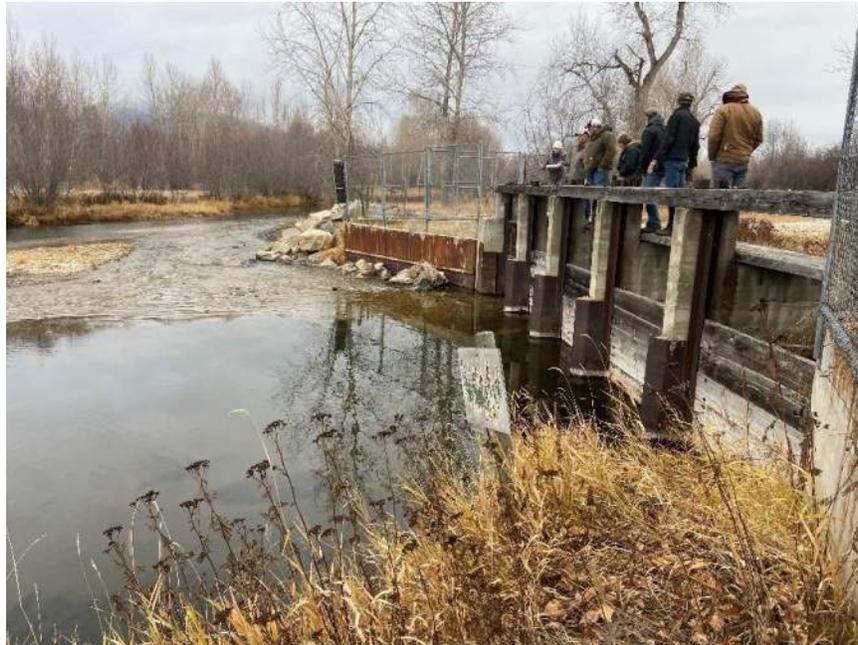
Figure 39: Tucker Headgate

The Tucker headgate is a concrete structure with steel wrapping the concrete walls and five wood slide gates with steel guides and metal rings used to manually hook and lift the gates. The structure has a concrete slab base.
