Bitterroot Conservation District

Bitterroot River Irrigation Management Study

December 2022

**Bitterroot Conservation District
Bitterroot River Irrigation Management Study**

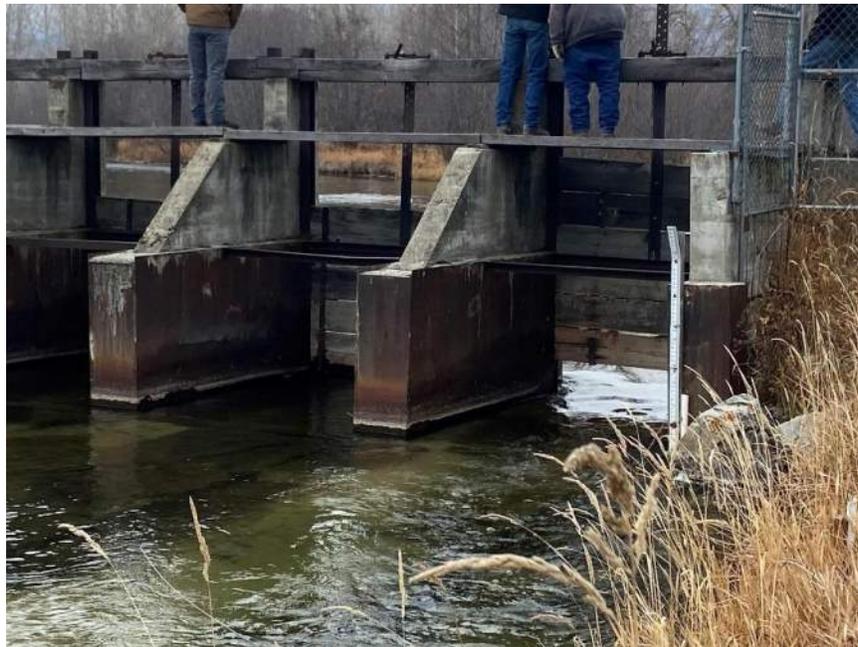
Figure 40: Tucker Measurement Gage

There is a staff gage on the downstream side of the headgate at the structure and another gage downstream of the structure in a natural-bottom, irregular cross section. Because flow is not uniform at the gates and because the downstream cross section is subject to change, the accuracy of any calibration curve at either location is questionable.

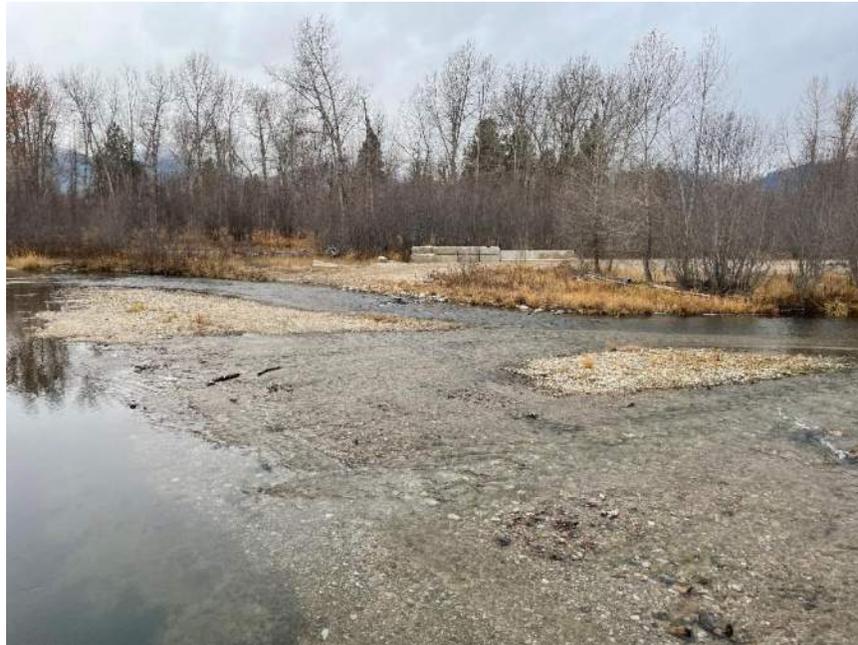
Figure 41: Tucker Diversion

Concrete eco-blocks are installed each spring to divert water from the East Channel towards Tucker headgate. Gravel is then used to fill in the gaps between eco-blocks. This installation and removal process costs approximately \$3,000 each year but is still limited in its effectiveness depending on the water level of the East Channel. Sediment buildup at the inlet of the gates is an issue and often requires dredging with heavy equipment to keep water flowing through the ditch. Lining the eco-blocks with a tarp and then placing the gravel could enhance the functionality.

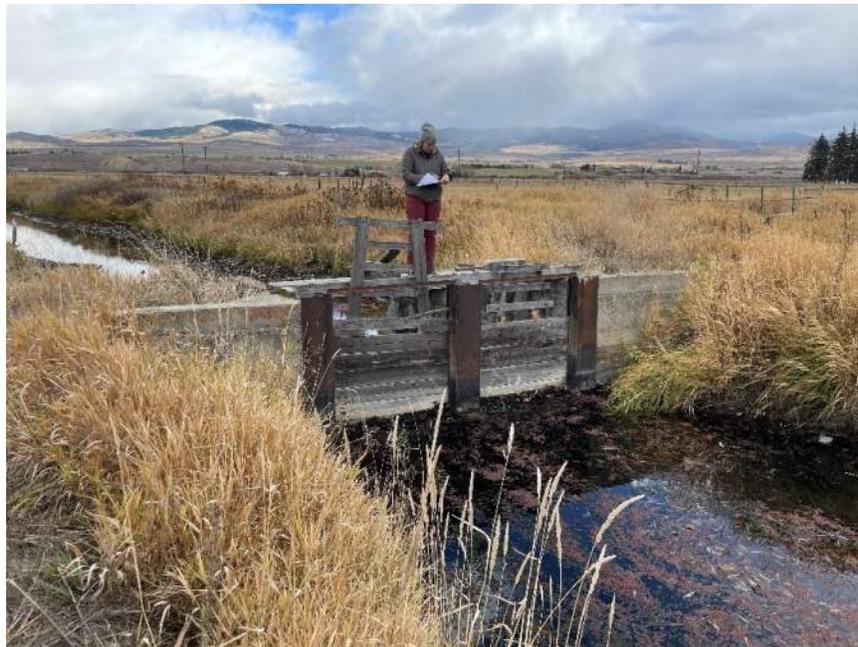
Figure 42: Union Headgate

The Union headgate is a concrete and wood structure that is outdated. The concrete has cracks, signs of weathering and the concrete floor and footers are deteriorating. There are two wood slide gates, approximately 5 feet wide, and the gates must be adjusted by hand. The wood walkway planks and slide gates are rotting and splintered, and there is no handrail, presenting a safety risk to operators. The operator did not report any issues with headgates limiting flow.

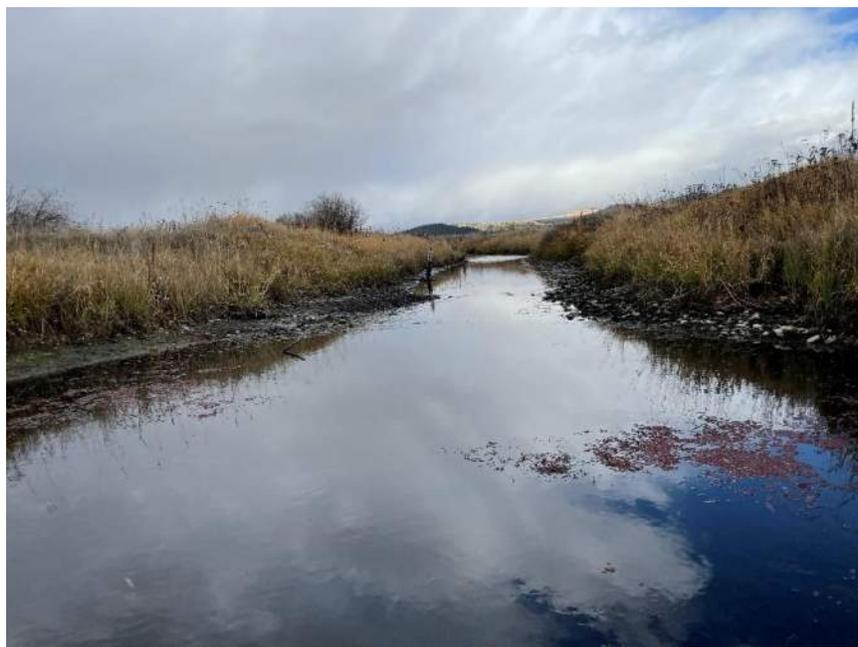
Figure 43: Union Measurement Gage in Channel

There is a staff gage approximately 100 feet downstream of the headgate structure in a natural-bottom channel with an irregular cross section. Because of the potential variability in the cross section from year to year due to sedimentation, erosion, and vegetation, the accuracy of any calibration curve is questionable.

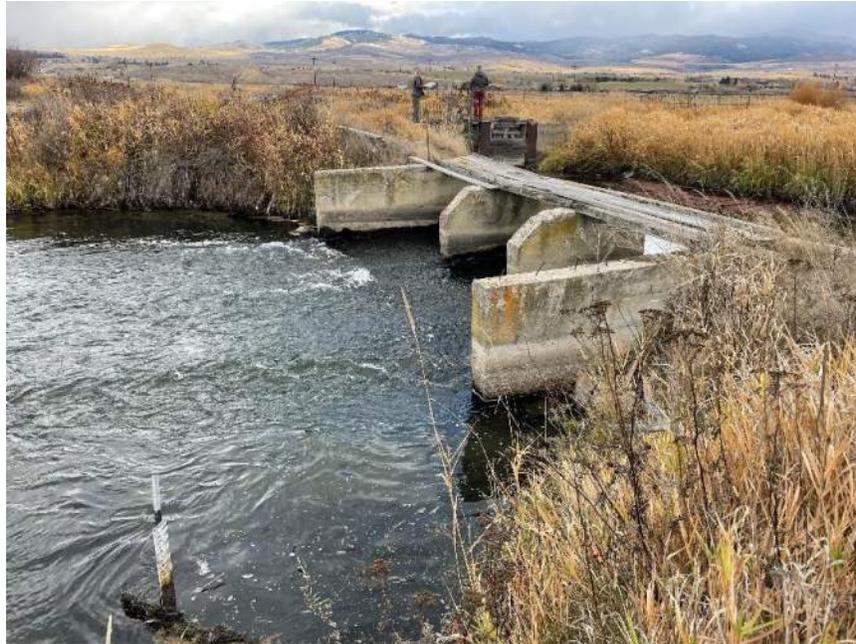
Figure 44: Union Diversion

The Union diversion supplies the ditch with water from Michell Slough and is comprised of three concrete gate structures, 4 feet deep by 7 feet wide each, with stop logs placed in steel guides to regulate the water level. There is evidence of erosion and eddies behind the diversion walls. The bottoms of the diversion walls have lost some concrete. There are multiple, unsecured boards stacked across the diversion as a walkway and no handrail, posing a safety hazard.

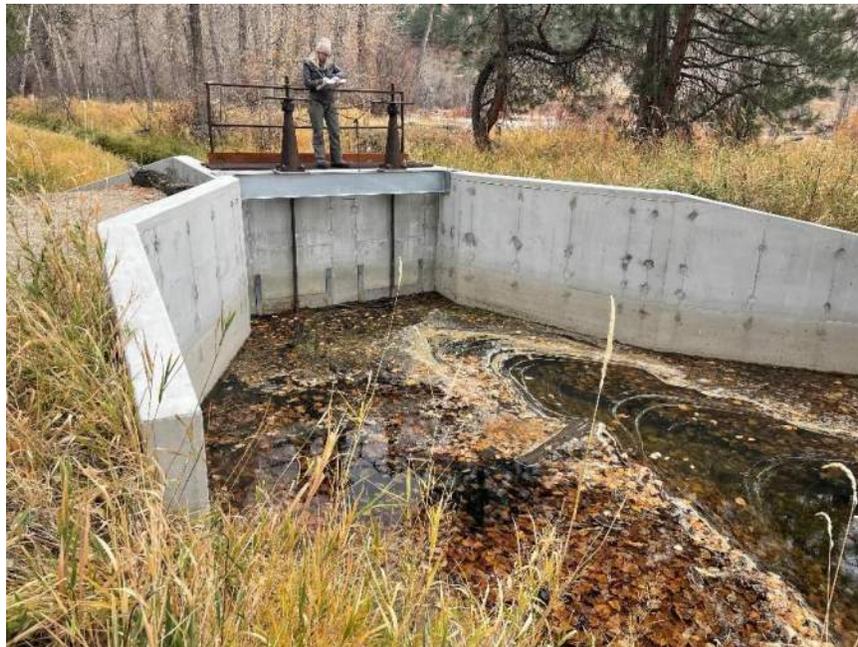
Figure 45: Ward Headgate

The Ward headgate was replaced in 2018 and is in good condition. The structure is comprised of new concrete and two metal headgates that can be adjusted with a handwheel. There is a metal grate walkway set into the headgate structure with a handrail. Debris building up at the headgate is a recurring issue.

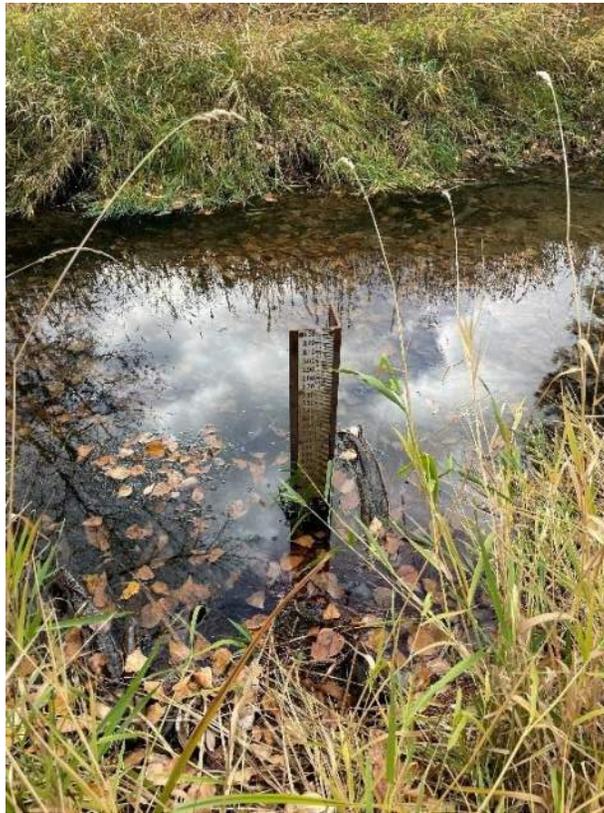
Figure 46: Ward Measurement Gage in Channel

There is a flow measurement gage approximately 100 feet downstream of the headgate in a natural-bottom, irregular cross section of the channel. Because of the potential variability in the cross section from year to year due to sedimentation, erosion, and vegetation, the accuracy of any calibration curve is questionable. There is also a wood flume in the ditch. However, because it is located downstream of the Lost Horse Siphon, the Ward Irrigation District's headgates off Lost Horse Creek, and at least one turnout off the ditch, this flume cannot be used to accurately assess flows being diverted from the Bitterroot River.

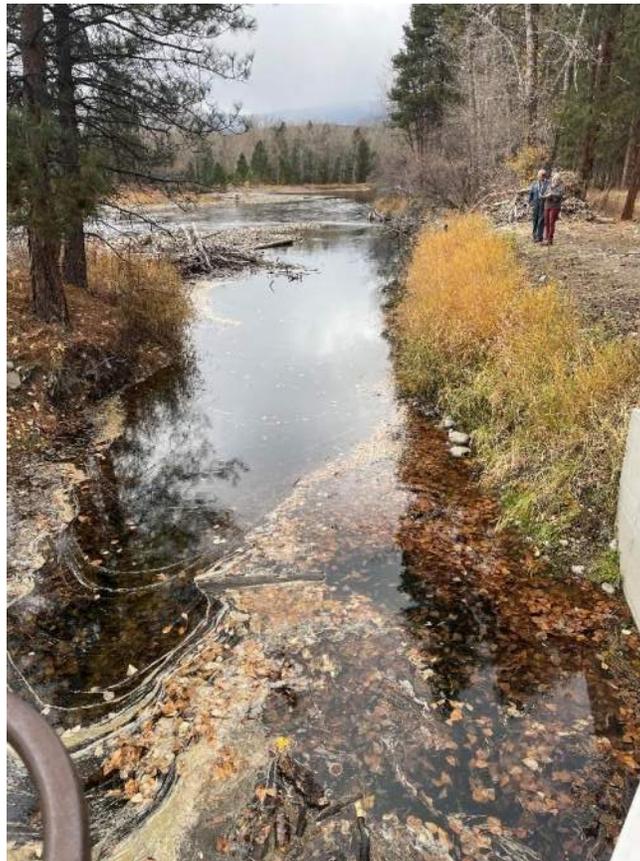
Figure 48: Ward Diversion

A rock bar comprised of river rock, logs, and imported 2-foot boulders is annually rebuilt with equipment in the main channel of the Bitterroot River to divert water flow into Ward ditch. The rock bar extends into the channel only a fraction of the overall width. River migration and down cutting is a concern that presents the potential for loss of flow delivery to the system. Debris accumulation is an issue and flows fluctuate each year at the diversion.

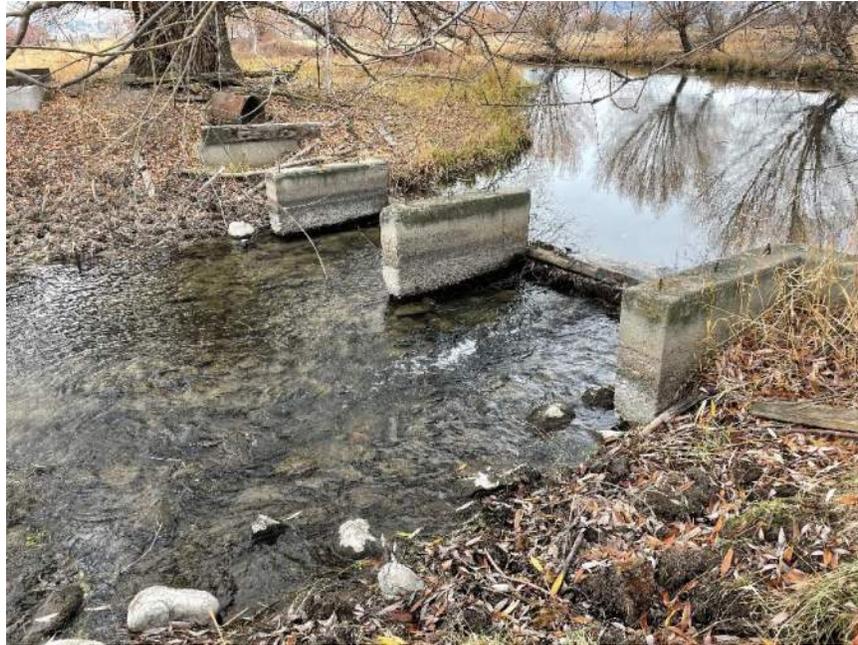
Figure 49: Webfoot Headgate

concrete pillars and floor slabs show signs erosion and spalling and could be replaced. The banks are relatively low and are susceptible to water flowing around the headgate structure during high flows.

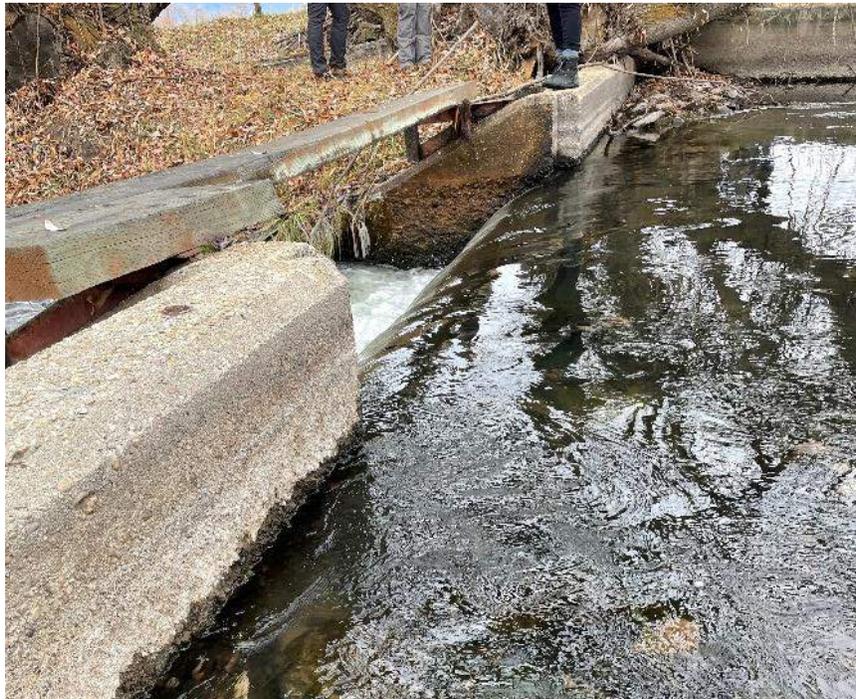
Figure 50: Webfoot Check Dam Diversion

An in-stream check-dam is used to divert water from Mitchell Slough into the ditch. The check-dam is constructed of a concrete structure with stop logs that are hand placed in the spring and removed in the winter. There is some loss of the concrete at the upstream corners of the structure. There are no metal guides for stop logs and they are held into a notch in the concrete by the pressure of flowing water. There is no further control of the flow of water once the logs are in place. Water is known to overtop the diversion structure during high water.

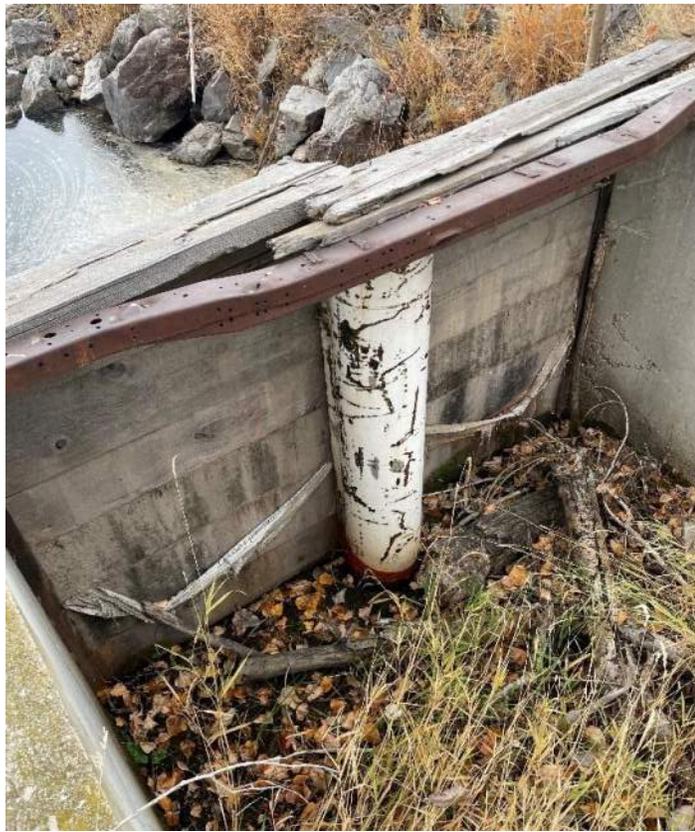
Figure 51: Woodside Headgate

The Woodside Headgate consists of two 24-inch diameter corrugated metal pipes under a concrete slab, on top which sits the concrete walls that formed the previous gate structure. The old concrete gate opening is permanently blocked by wooden stop logs that are bolted to a 12-inch diameter steel pipe that is set into the concrete slab. The 24-inch pipes were installed in 2002 and lowered the inlet elevation of the headgate by approximately 30 inches. The amount of water through the double pipes is sufficient throughout the irrigation season and usually must be regulated. Regulation is accomplished by placing a steel plate with handle across all or part of one or both pipes. There is a wooden board and irregularly shaped steel beam placed across the top of the structure to allow for crossing, but safety of the walkway could be improved by a wider, more consistent walkway with handrail.
