Bitterroot Conservation District

Bitterroot River Irrigation Management Study

December 2022

**Bitterroot Conservation District
Bitterroot River Irrigation Management Study**

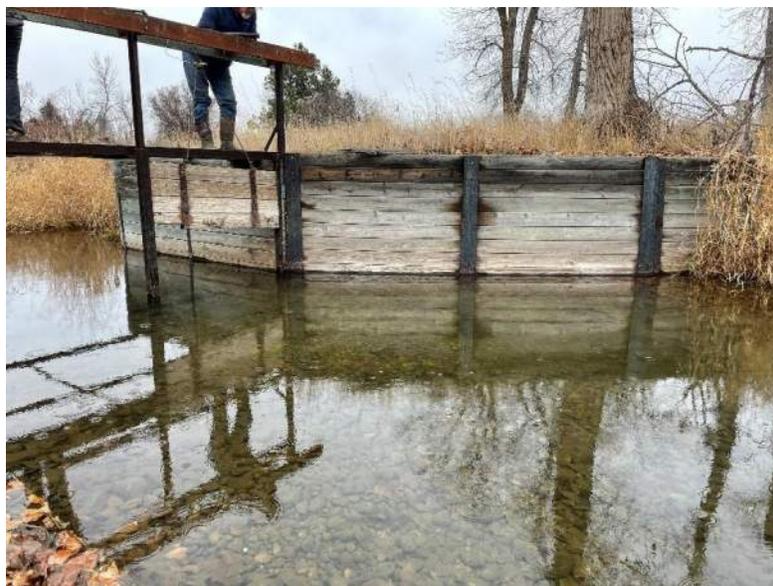
Figure 3: Bill Strange Headgate

The Bill Strange headgate is comprised of two wood paneled slide gates that are lowered on cables by hand. The wood at the structure shows signs of weathering and could be replaced eventually but is currently in good overall condition. There are metal beams supporting the connected wood panels. The base of the structure has wood panels that show some erosion and allowed water to flow underneath. There is a wood board walkway across the ditch that presents opportunity for improvements and a handrail could be installed to improve safety.

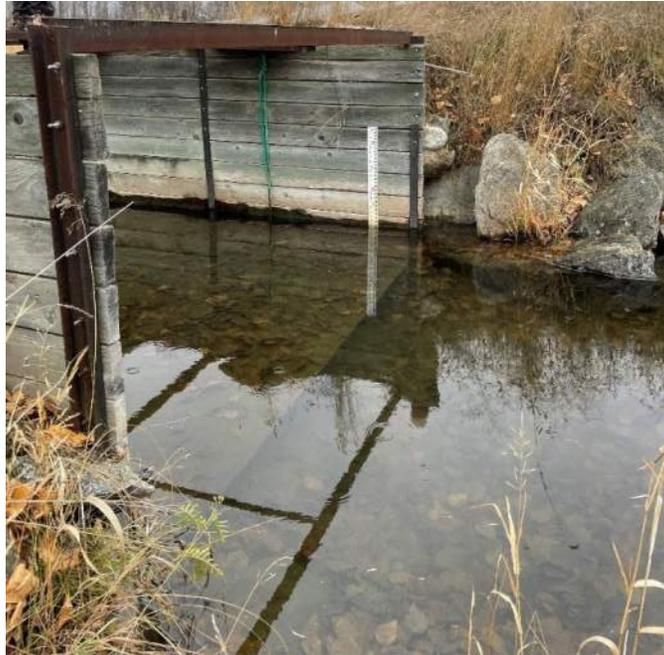
Figure 4: Bill Strange Measurement Gage

There is a staff gage at the headgate structure. Because flow is non-uniform through the structure, the accuracy of any associated stage-discharge calibration curve is questionable. Because channel geometry near the staff gage may change over time, it is recommended that the calibration curve be periodically checked for accuracy.

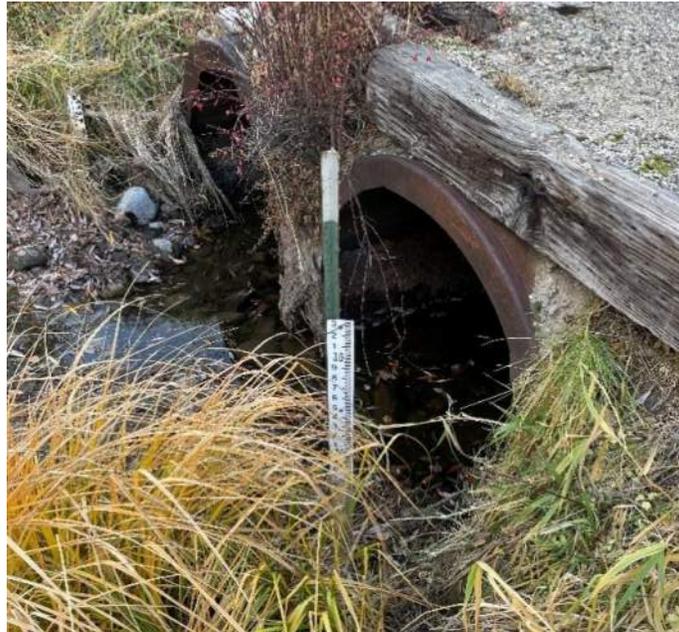
Figure 52: Woodside Flow Measurement Gage

The flow measurement for the Woodside ditch is located approximately three-quarters of a mile down the ditch from the headgate and after the ditch water intermingles with Blodgett Creek. The placement at this site alone would merit a condition rating of Poor because the contributions of Bitterroot River/Painted Rocks water cannot be independently measured. The flow measurement consists of a staff gage placed in front of the right-hand culvert in a set of two smooth metal culverts that are both approximately 48 inches in diameter. The placement so close to a hydraulic structure means that flow will be varied, rather than uniform, resulting in an inability to generate an accurate calibration curve at this location.

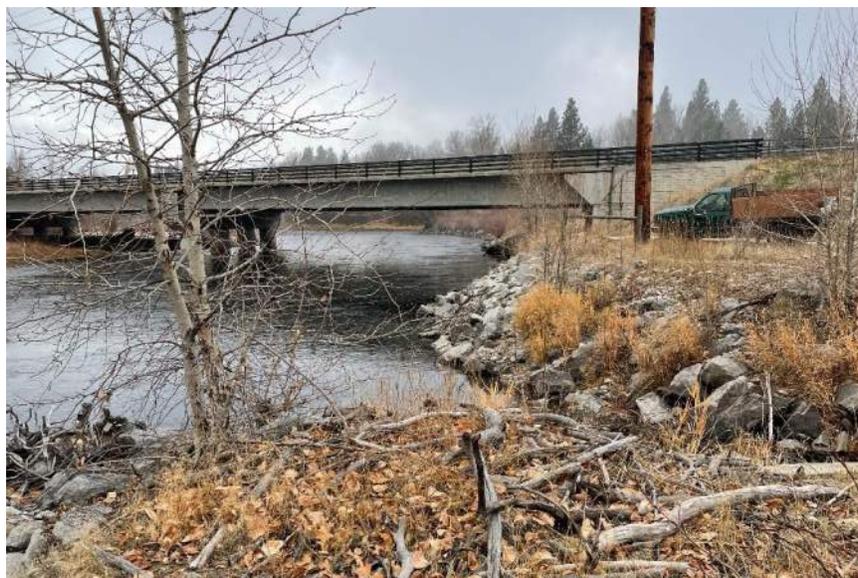
Figure 53: Woodside Diversion

There is no dedicated diversion structure at the Woodside Ditch. Water is diverted in a relatively stable reach of the main Bitterroot River channel and there have been no issues getting sufficient flow into the ditch.

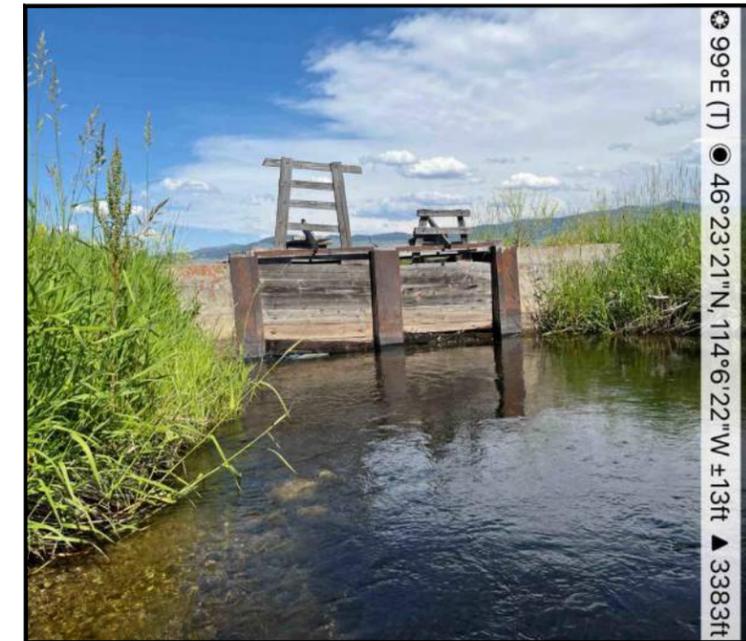
① EXISTING UNION HEADGATE

A complete structure replacement is recommended because the existing structure does not meet modern design standards, is well past its reasonable service life, and would require such extensive rehabilitation that it likely would offer little to no cost savings. The new structure will consist of a concrete headwall and wingwalls keyed into the banks on both sides, a new foundation slab with a cutoff wall at the upstream end, and new internal wall that allow for mounting of new slide gates. The headwall and cutoff wall must be keyed into the ground to scour depth or frost depth, whichever is greater, to prevent future instabilities of the structure. These features are critical to prevent the erosive forces of water of cutting around or under the structure.

Because the Union system operator did not report issues with the headgates limiting flow, the existing configuration of two gate openings will be kept and sized to match the existing openings. Two new rectangular slide gates will be installed to regulate the headgates. Slide gates will be actuated by manual handwheels that will be accessible from a new metal walkway over the structure. The new metal walkway will greatly improve operator safety. Additional safety features that should be incorporated should also include toe kicks, handrails, and safety clips for harnessing during O&M activities.

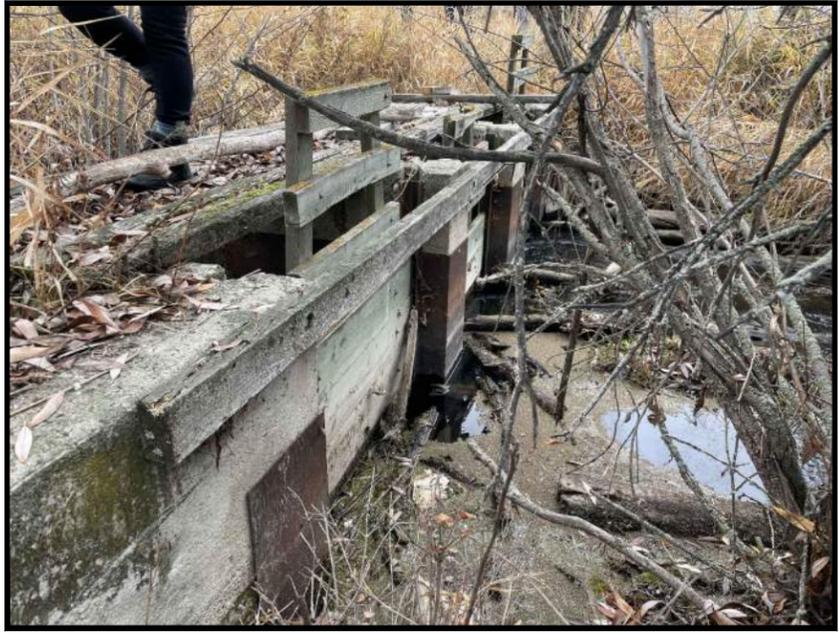
1 EXISTING ETNA HEADGATE

A complete structure replacement is recommended because the existing Etna headgate structure does not meet modern design standards, is well past its reasonable service life, and would require such extensive rehabilitation that it likely would offer little to no cost savings. The new structure will consist of a concrete headwall and wingwalls keyed into the banks on both sides, a new foundation slab with a cutoff wall at the upstream end, and a new internal wall that allows for mounting of new slide gates. The headwall and cutoff wall must be keyed into the ground to scour depth or frost depth, whichever is greater, to prevent future instabilities of the structure. These features are critical to prevent the erosive forces of water of cutting around or under the structure. It may be necessary to clear some vegetation that grows between the Etna headgate and diversion to complete construction, which could improve the problem of vegetation getting swept into the ditch. If this will not be sufficient, screening of the ditch inlet can be added to the design.

Because the Etna system operator did not report issues with the headgates limiting flow, the existing configuration of three gate openings will be kept and sized to match the existing openings. Three new rectangular slide gates will be installed to regulate flow through the headgate. Slide gates will be actuated by manual handwheels that will be accessible from a new metal walkway over the structure. The new metal walkway will greatly improve operator safety. Additional safety features that should be incorporated include toe kicks, handrails, and safety clips for harnessing during operations and maintenance (O&M) activities.

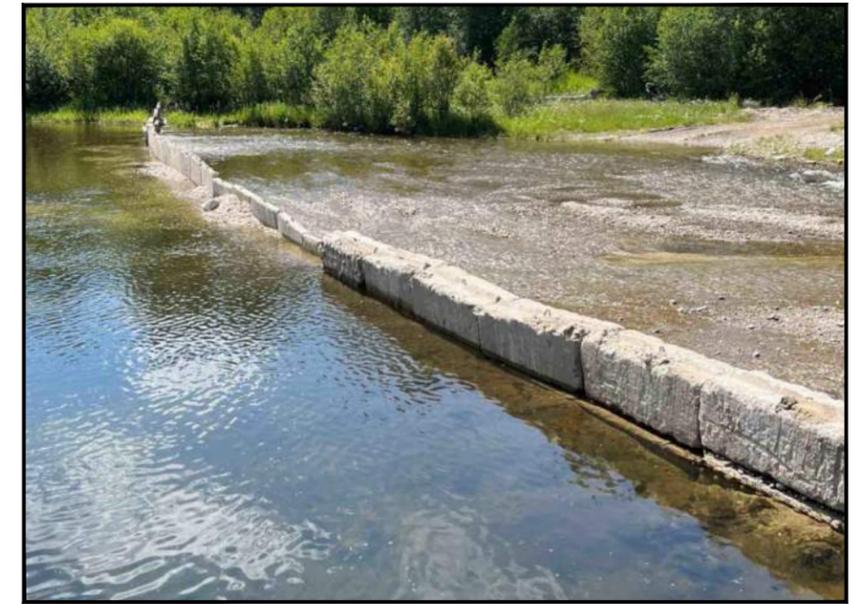
1 TUCKER DIVERSION

The Tucker intake is the first diversion from the East Channel and delivers water into Mitchell Slough, which serves numerous irrigation systems including Union, Etna, Webfoot, and other large ranches. The diversion structure is in fair condition; concrete eco-blocks are installed each spring to direct water towards the Tucker headgate, and gravel is used to fill the gaps between the eco-blocks. The annual installation and removal costs approximately \$3,000 associated with primarily labor and equipment to remove and install the concrete blocks, but low water levels in the East Channel can still limit the effectiveness of the diversion. The existing diversion presents challenges due to aggradation (sediment deposition) upgradient of the concrete eco-block diversion, which can impede flow through the Tucker headgate. It is necessary to remove the structure post season to prevent continued aggradation. The eco-blocks are installed after spring runoff as sufficient water surface elevations are present without the use of the concrete blocks during high water. In addition, the stability of the eco-blocks is at risk during the higher flows of spring runoff. This diversion has one of the largest cumulative water rights of those surveyed, and therefore improvements to this structure will be relatively impactful for users and in terms of water management.

The proposed recommendation for the Tucker diversion is an adjustable diversion. An adjustable diversion is necessary to allow passage of high water associated with sediment transport by removing the diversion structure and allows for grade control during mid- and late-irrigation season flows through installation of the diversion structure. The existing eco-block concrete diversion is classified as an adjustable diversion; however, the challenges associated with the functionality of the structure include lack of incremental grade control through the ability to set only one elevation that is associated with the top of block, seepage between the concrete eco-blocks and stability of the eco-blocks during higher flow conditions. While aggradation and sediment issues will exist regardless of a permanent or adjustable diversion, the ability to adjust (lower) the diversion during portions of the year will allow for some natural flushing processes to mobilize some sediment and reduce the potential for additional sediment accumulations. Options for adjustable diversions include a stop log system as a lower cost solution or an inflatable rubber bladder diversion as a higher cost solution. These options present unique considerations, and for the purposes of this report, the lower cost stop log diversion is discussed.

1 PROPOSED TUCKER DIVERSION CONCRETE PAD W/ BREAKOVER JACK

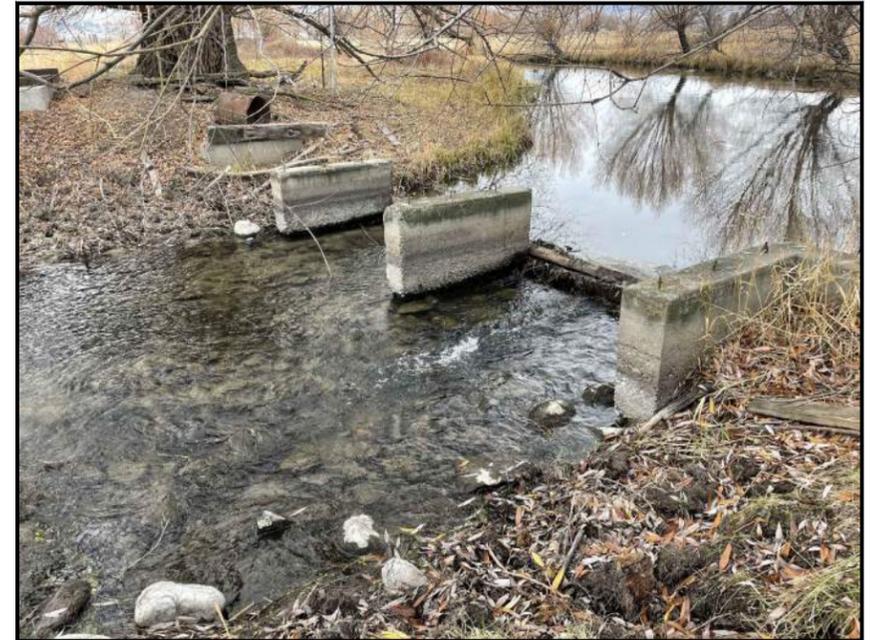
① EXISTING WEBFOOT HEADGATE

The Webfoot Headgate is located at the last diversion off Mitchell Slough, near Victor Crossing. It consists of a concrete check with three openings with stop logs. While the headgate is in fair condition, the stop logs must be placed manually, and the right-most opening is filled with sediment and is no longer active. Once the logs have been placed, there is no way to adjust flows. The concrete floor slabs and pillars show signs of spalling and erosion. The banks surrounding the headgate are relatively low, and high waters may overtop the banks and compromise the structure.

The existing Webfoot headgate should be replaced with a new concrete structure, coupled with re-grading of the banks to constrain flows to the headgate openings and fencing off the structure to prevent erosion due to livestock. The new structure would consist of a concrete headwall and wingwalls keyed into the banks on both sides, a new foundation slab with a cutoff wall at the upstream end, and three new handwheel-operated slide gates. The operators report that the existing headgate does not prevent them from getting the needed flows, even though the left opening is almost entirely filled in with sediment and has been that way for long enough that vegetation is actively growing. Therefore, the new openings should be constrained to the right and middle bays. The left bank, where overtopping is reported, should be built up, starting from the current divider wall between the middle and left openings, to prevent overtopping and subsequent erosion of the bank. The right-hand portion of the headgate should be re-configured into three openings, as slide gates that span the existing eight-foot-wide openings would be difficult to actuate. They should be equipped with metal slide gates with handwheels that can be operated from a new metal walkway. The walkway should include toe kicks, a railing, and attachment points to harness into for O&M activities.

② NEW HEADGATE STRUCTURE

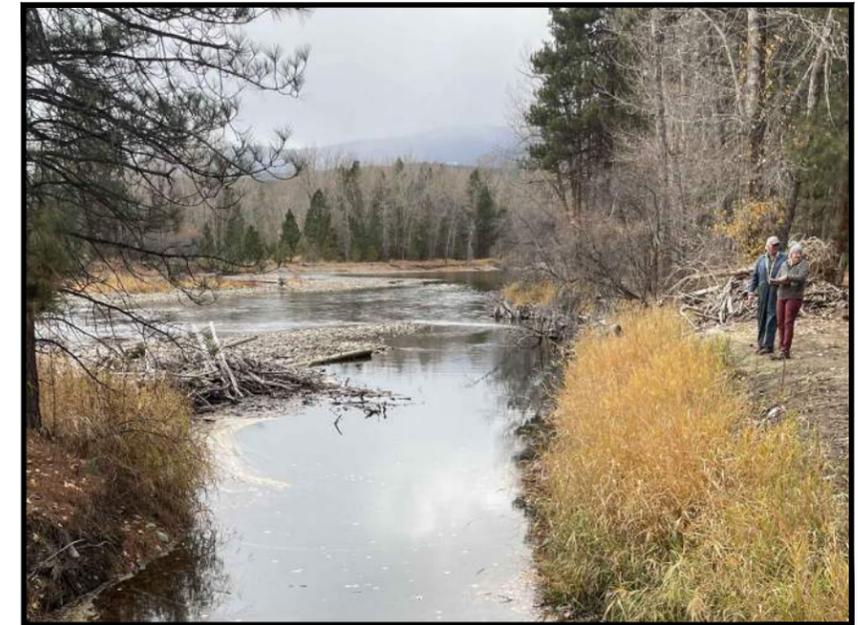
1 EXISTING WARD DIVERSION

The Ward diversion is located on the main stem of the of the Bitterroot River near Charlos Heights, Montana. The diversion is a very short and partially spanning structure comprised of river rock, log, and debris. While the diversion is currently in fair condition, it must be rebuilt annually and only spans a small portion of the channel. Accordingly, river migration, downcutting, debris, and fluctuating flows may all pose long-term risks to the ability of the Ward Irrigation District to deliver sufficient and regular flows. High potential for obtaining funding and high stakeholder engagement were also noted with regards to this site. Topographic survey data from the Ward diversion location was collected in 2018 and August 2022. No identifiable change in streambed elevation was observed between these two dates.

A full spanning grade control structure is necessary to grade and control the extents of this segment of the river. A grade control structure would be comprised of large diameter rock keyed into the bed of the channel. The rock would not need to protrude into the channel but keyed in at grade to maintain consistent elevations. The rock would need to be sized to withstand tractive forces from large runoff events such as the 100-year flood. Abutment walls would be necessary to key the grade control to the adjacent banks. Permitting challenges with this type of diversion would be very significant and might require mitigation requirements set forth by the United States Army Corps of Engineers and the United States Fish and Wildlife Service.

1 PROPOSED WARD DIVERSION
SCALE: N.T.S.

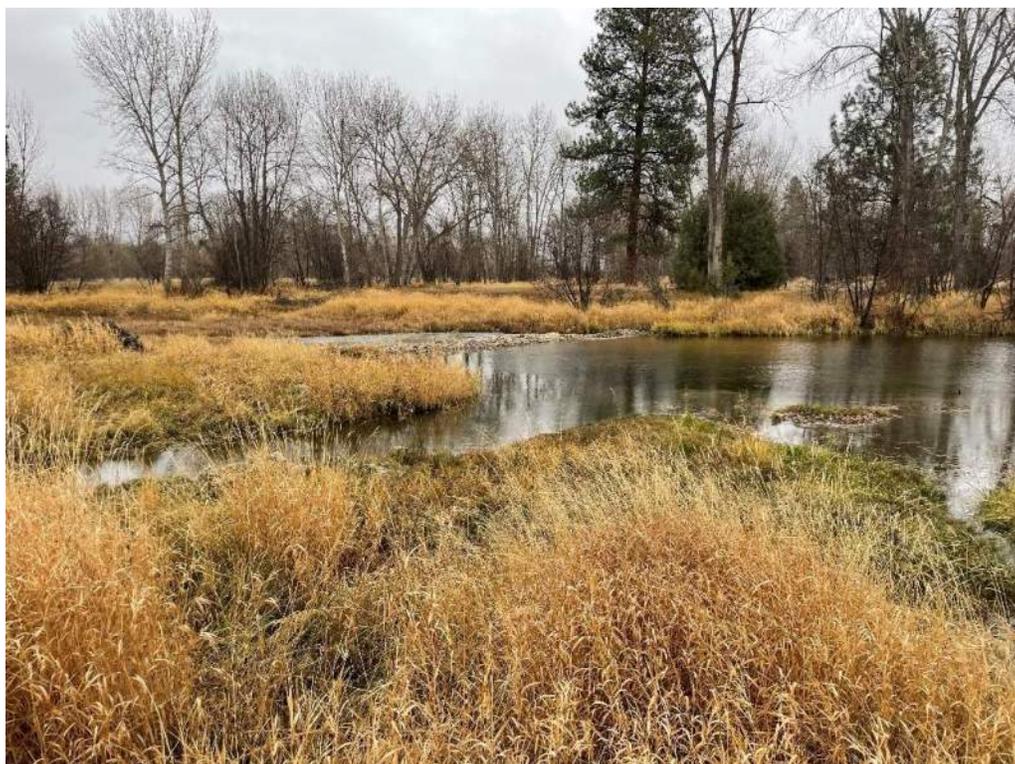
Figure 20: River Ditch Diversion

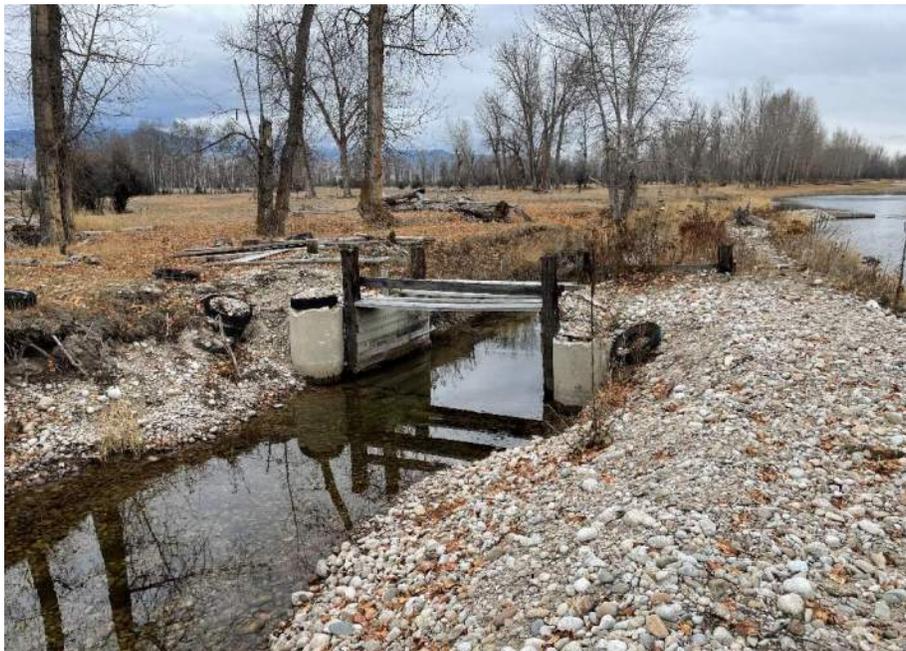
Figure 21: Spooner Headgate

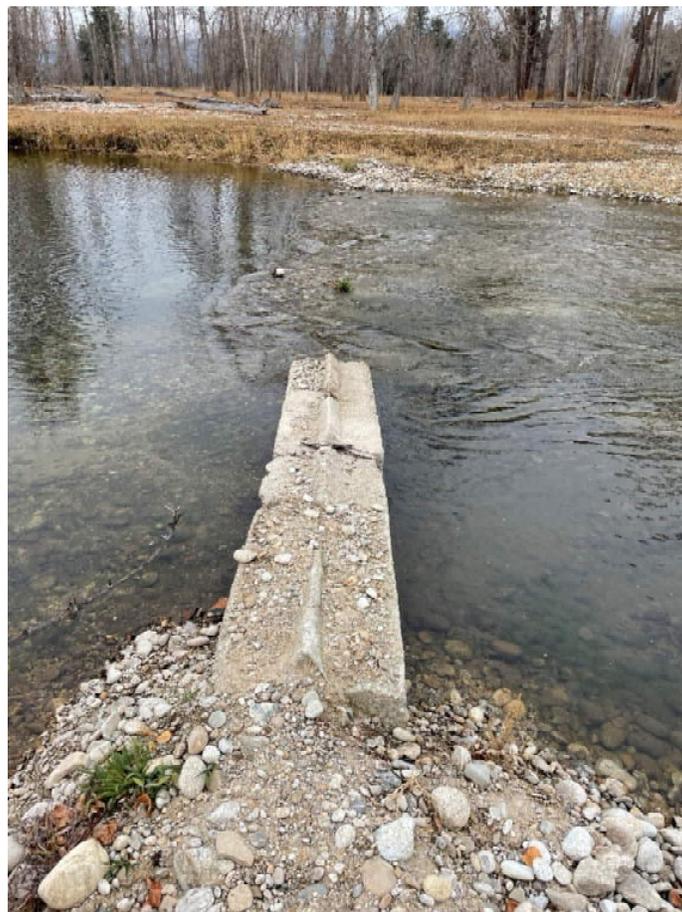
Figure 22: Spooner Diversion

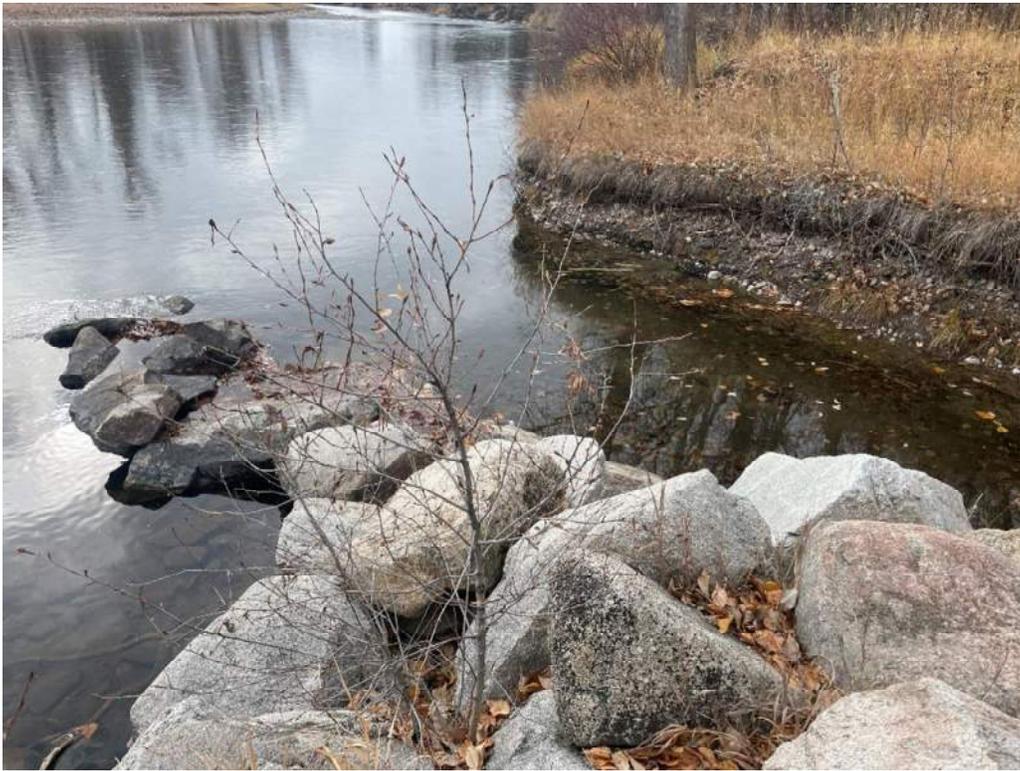
Figure 23: Tiedt Nicholson Diversion

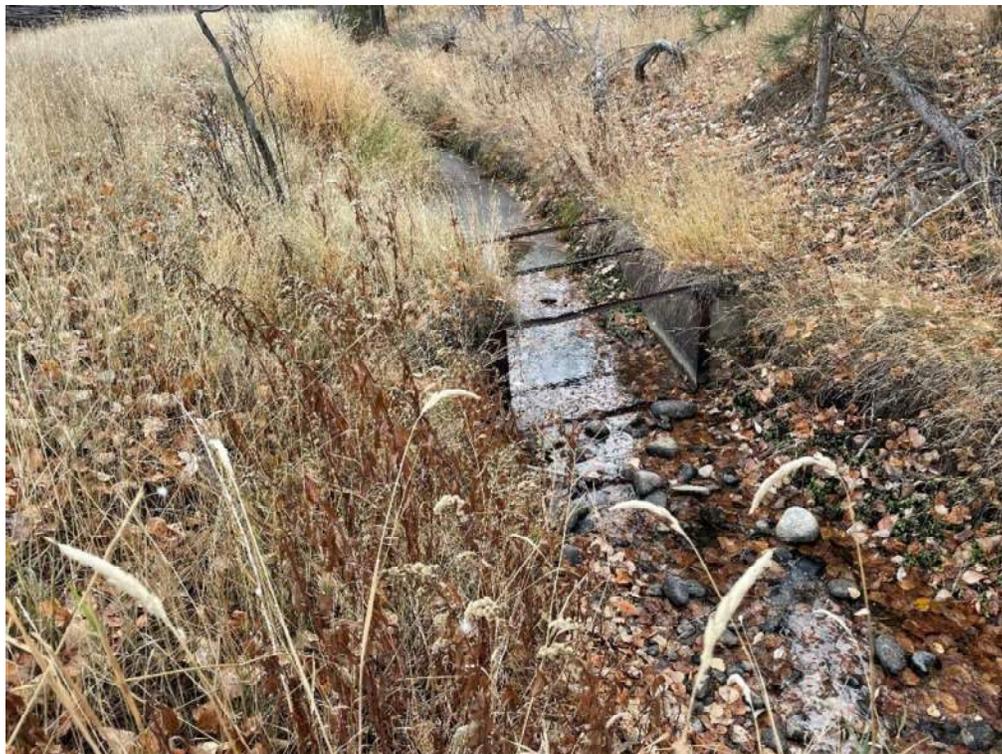
Figure 24: Tiedt Nicholson Metal Flume

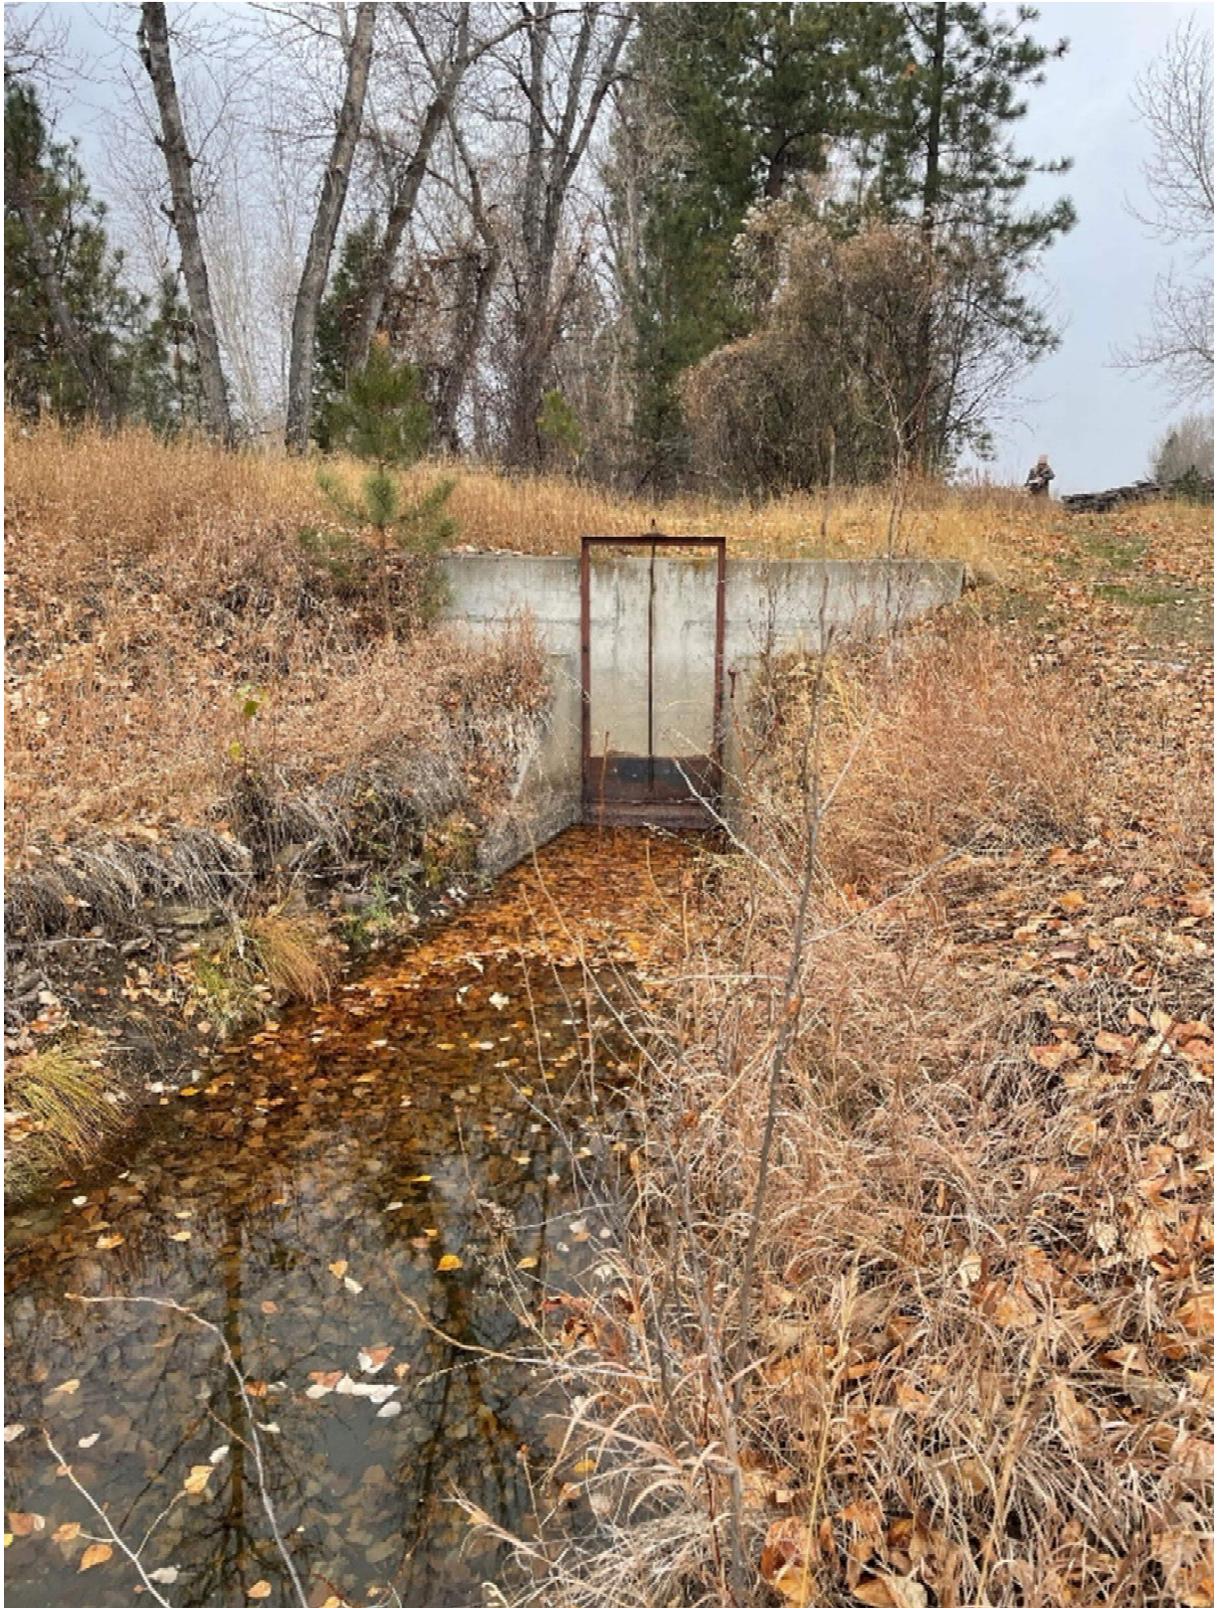
Figure 25: Tiedt Nicholson Headgate

| Rank | Ditch Name | Structure | Overall Score | RENEWABLE RESOURCE CONSERVATION WEIGHT = 0-4 | | RENEWABLE RESOURCE MANAGEMENT WEIGHT = 4 | | RENEWABLE RESOURCE PRESERVATION WEIGHT = 4 | | COMPLIANCE WEIGHT = 3 | | ENGAGEMENT WEIGHT = 2 | INFLUENCE WEIGHT = 3 | | FUNDING POTENTIAL WEIGHT = 2 | | SAFETY WEIGHT = 2 | |
|---|---|---|---|---|--|---|--|---|---|---|---|---|---|---|---|--|---|---|
| 51 | Tiedt Nicholson | Headgate | 36.6 | 1 | Good - Functioning slide gate | 2 | Functioning Headgate | 1 | Good | 1 | Functional | 3 | 0.2 | 7.8 / 312 | 3 | Non-priority headgates given a default score of 3 | 1 | No additional safety features recommended |

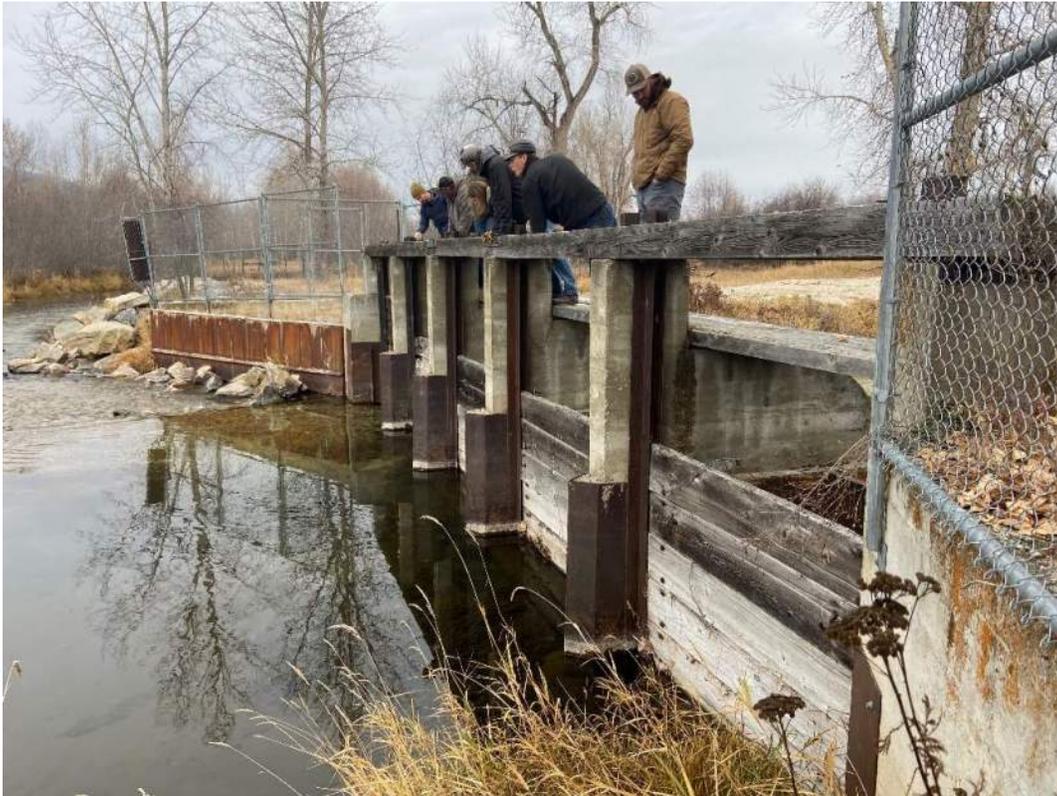
Figure 26: Tucker Headgate

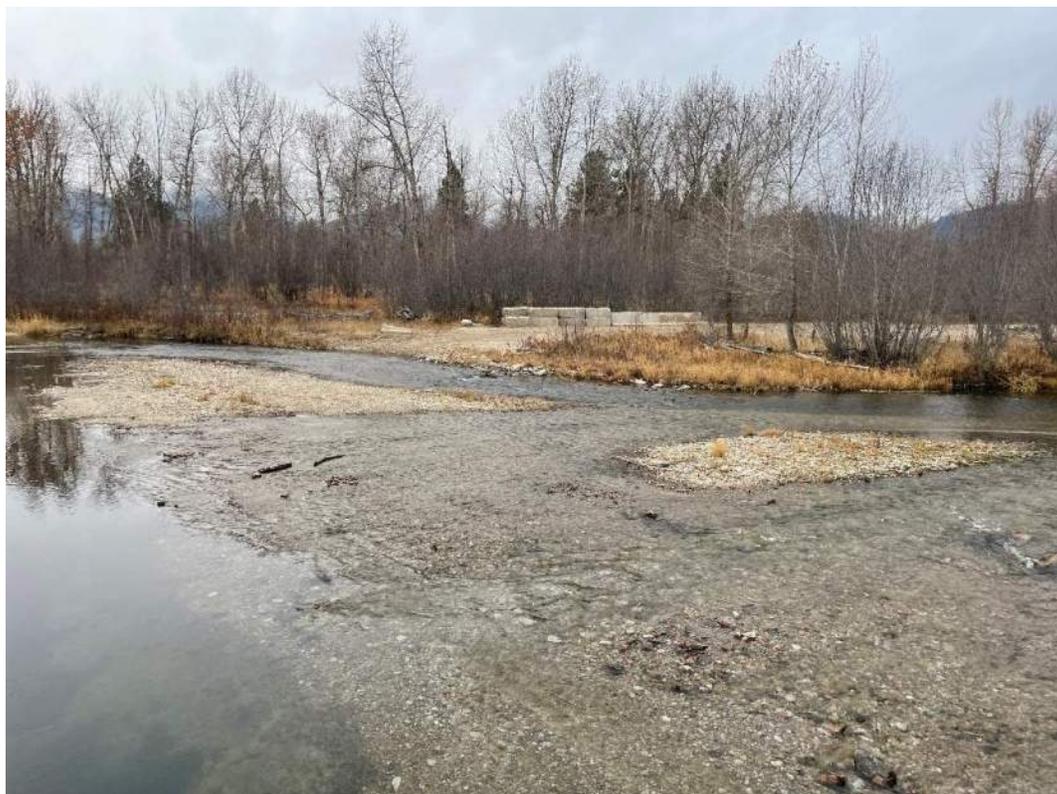
Figure 27: Tucker Diversion Location

| Rank | Ditch Name | Structure | Overall Score | RENEWABLE RESOURCE CONSERVATION WEIGHT = 0-4 | | RENEWABLE RESOURCE MANAGEMENT WEIGHT = 4 | | RENEWABLE RESOURCE PRESERVATION WEIGHT = 4 | | COMPLIANCE WEIGHT = 3 | | ENGAGEMENT WEIGHT = 2 | INFLUENCE WEIGHT = 3 | | FUNDING POTENTIAL WEIGHT = 2 | | SAFETY WEIGHT = 2 | |
|---|---|---|---|--|--|--|---|--|---|---|---|---|---|---|---|--|---|--|
| 10 | Tucker | Diversion | 76.6 | 3 | All diversions given a 3, unless special conditions exist | 4 | Eco-blocks installed and gravel is placed to fill gaps - limited in effectiveness depending on water level of east channel. Sediment has to be dredged with heavy equipment to keep water flowing through the ditch | 3 | Fair | 1 | No impact on compliance | 3 | 4.2 | 176 / 7040 | 1 | >125K | 5 | Concrete eco-blocks installed/removed in East Channel each year. |

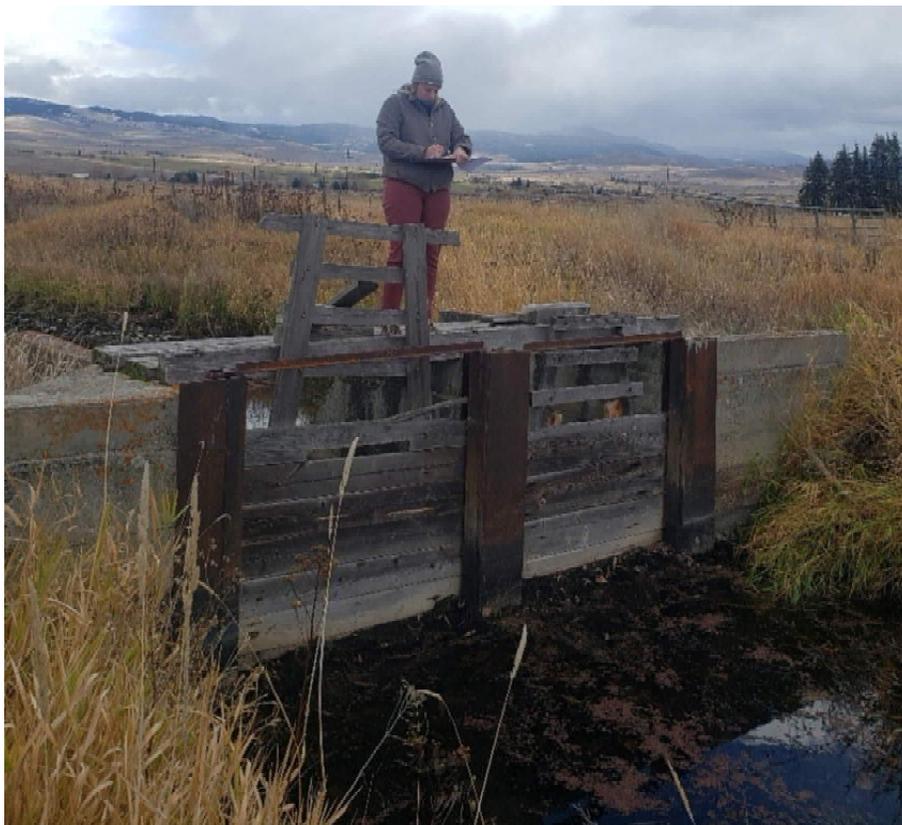
Figure 28: Union Headgate

| Rank | Ditch Name | Structure | Overall Score | RENEWABLE RESOURCE CONSERVATION WEIGHT = 0-4 | | RENEWABLE RESOURCE MANAGEMENT WEIGHT = 4 | | RENEWABLE RESOURCE PRESERVATION WEIGHT = 4 | | COMPLIANCE WEIGHT = 3 | | ENGAGEMENT WEIGHT = 2 | INFLUENCE WEIGHT = 3 | | FUNDING POTENTIAL WEIGHT = 2 | | SAFETY WEIGHT = 2 | |
|---|---|---|---|--|--|--|---|--|---|---|---|---|---|---|---|--|---|--|
| 1 | Union | Headgate | 97.1 | 5 | Poor - significant leakage | 3 | Wood slide gates must be adjusted by hand | 5 | Poor | 3 | Needs improvement | 5 | 1.7 | 71 / 2840 | 3 | 25K-125K | 5 | Not structurally sound - must be adjusted by hand |

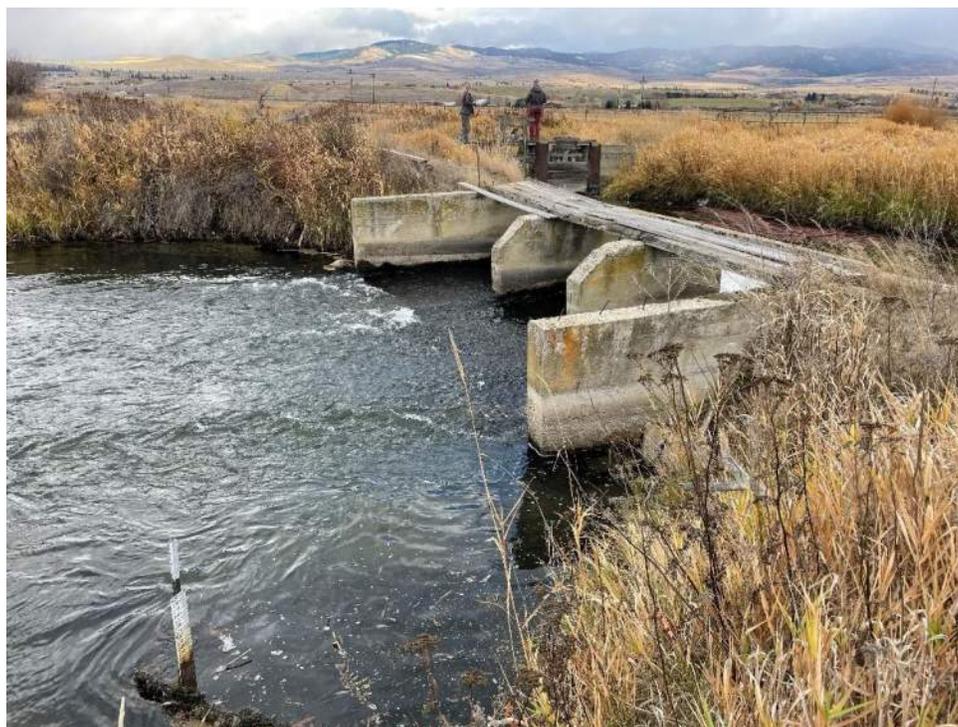
Figure 29: Union Diversion

| Rank | Ditch Name | Structure | Overall Score | RENEWABLE RESOURCE CONSERVATION WEIGHT = 0-4 | | RENEWABLE RESOURCE MANAGEMENT WEIGHT = 4 | | RENEWABLE RESOURCE PRESERVATION WEIGHT = 4 | | COMPLIANCE WEIGHT = 3 | | ENGAGEMENT WEIGHT = 2 | INFLUENCE WEIGHT = 3 | | FUNDING POTENTIAL WEIGHT = 2 | | SAFETY WEIGHT = 2 | |
|---|---|---|---|--|--|--|---|--|---|---|---|---|---|---|---|--|---|--|
| 4 | Union | Diversion | 85.1 | 5 | High risk of failure | 3 | Stop logs placed in steel guides | 5 | Poor | 1 | No impact on compliance | 3 | 1.7 | 71 / 2840 | 3 | 25K-125K | 5 | Deteriorating concrete walls, unsecured boards as walkway, no handrail |

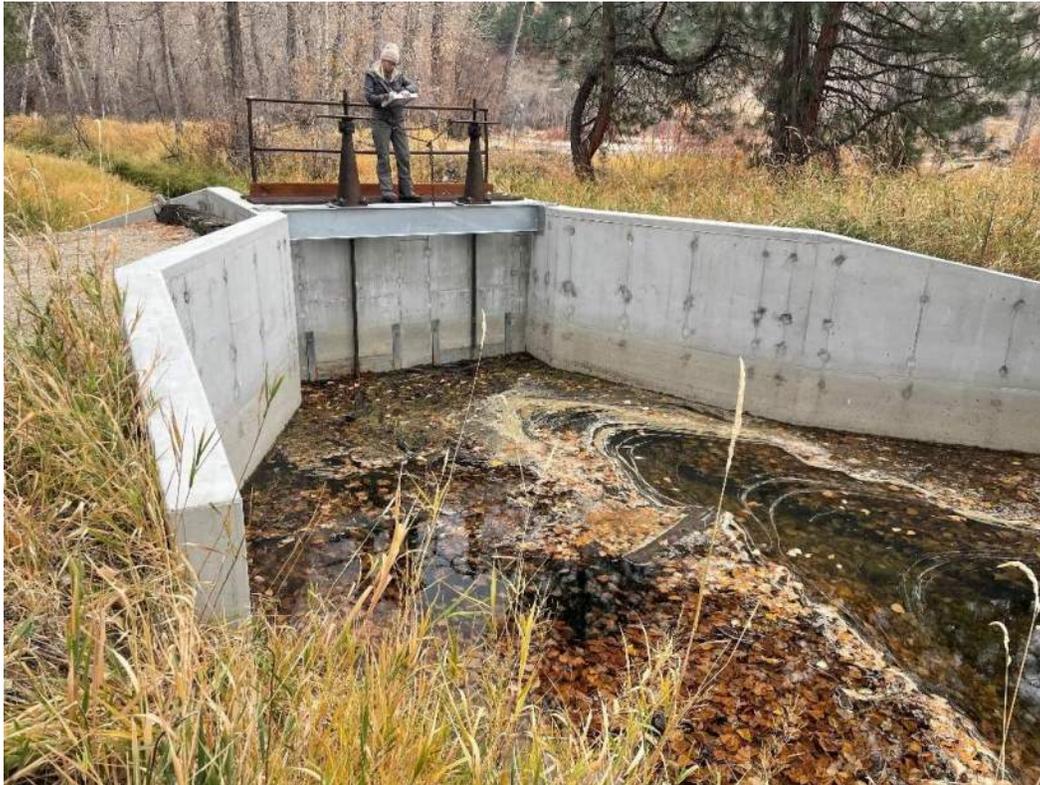
Figure 31: Ward Headgate

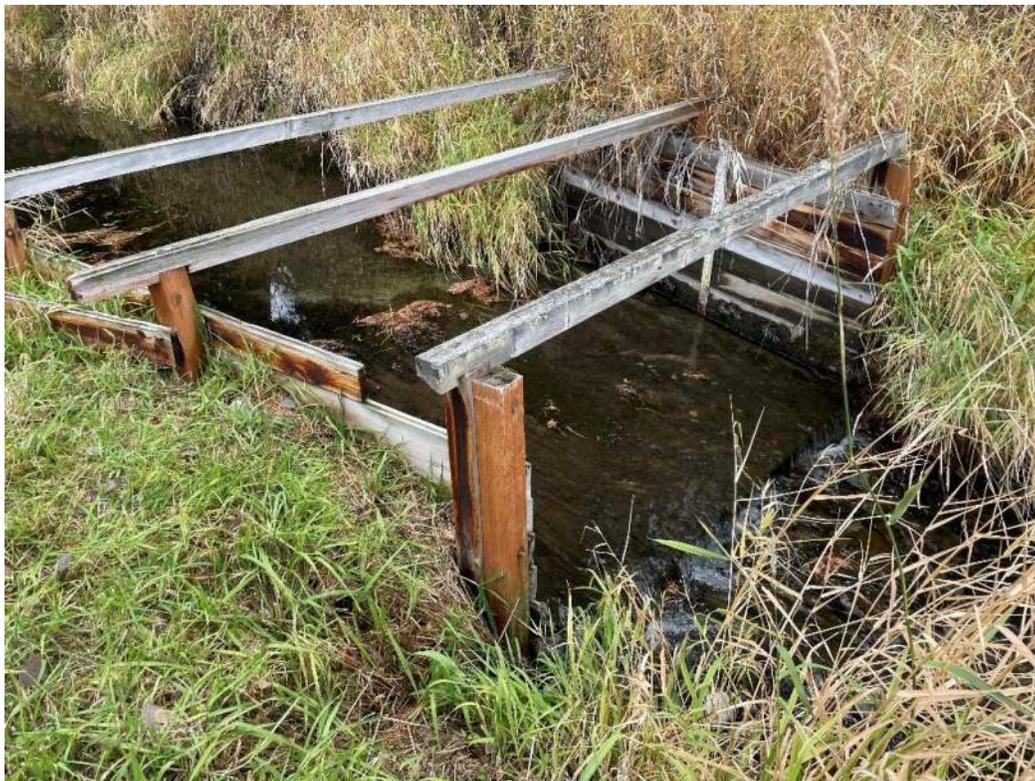
Figure 30: Ward Wooden Flume

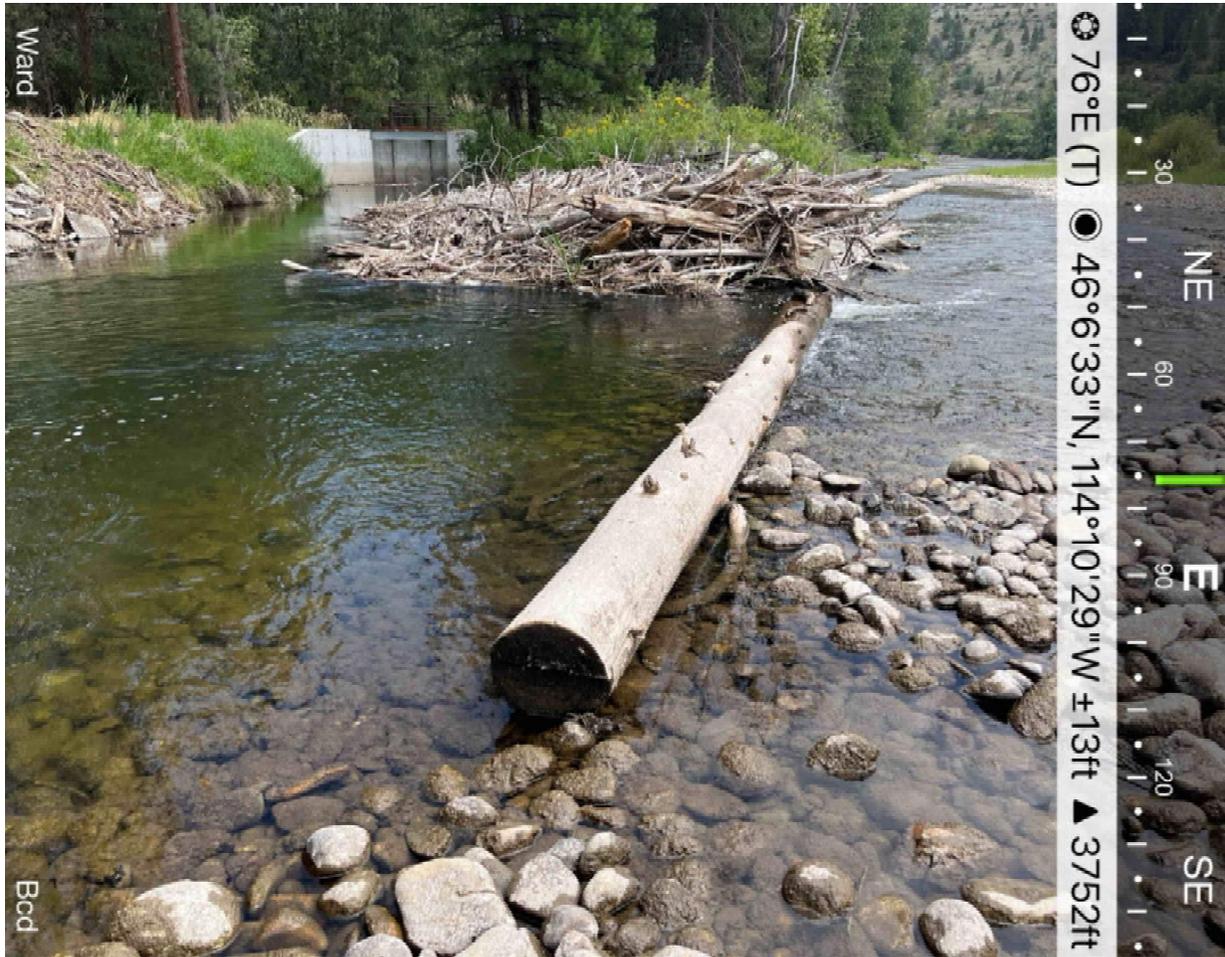
Figure 32: Ward Diversion

| Rank | Ditch Name | Structure | Overall Score | RENEWABLE RESOURCE CONSERVATION WEIGHT = 0-4 | | RENEWABLE RESOURCE MANAGEMENT WEIGHT = 4 | | RENEWABLE RESOURCE PRESERVATION WEIGHT = 4 | | COMPLIANCE WEIGHT = 3 | | ENGAGEMENT WEIGHT = 2 | INFLUENCE WEIGHT = 3 | | FUNDING POTENTIAL WEIGHT = 2 | | SAFETY WEIGHT = 2 | |
|---|---|---|---|--|--|--|---|--|---|---|---|---|---|---|---|--|---|--|
| 13 | Ward | Diversion | 72.2 | 3 | All diversions given a 3, unless special conditions exist | 4 | Rock bar annually rebuilt with heavy equipment in the main channel of the Bitterroot - Concerns of river migration | 3 | Fair | 1 | No impact on compliance | 5 | 0.7 | 30 / 1200 | 1 | >125K | 5 | Rock bar annually rebuilt in main channel of Bitterroot with heavy equipment |

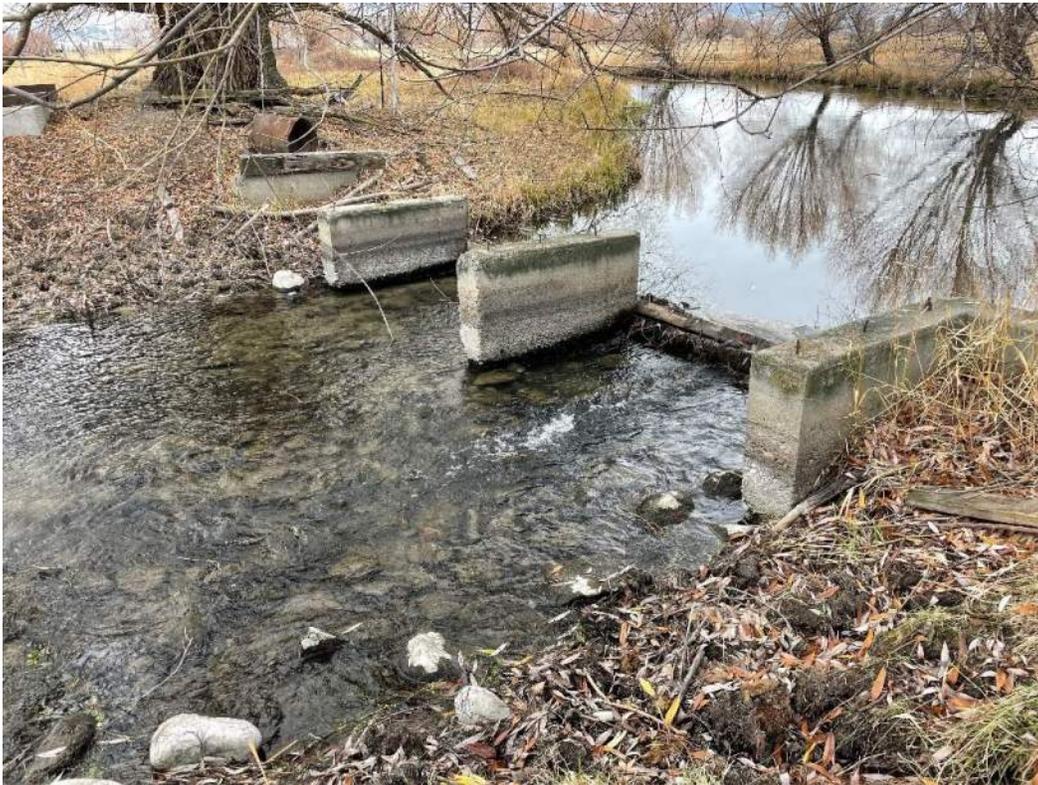
Figure 33: Webfoot Headgate

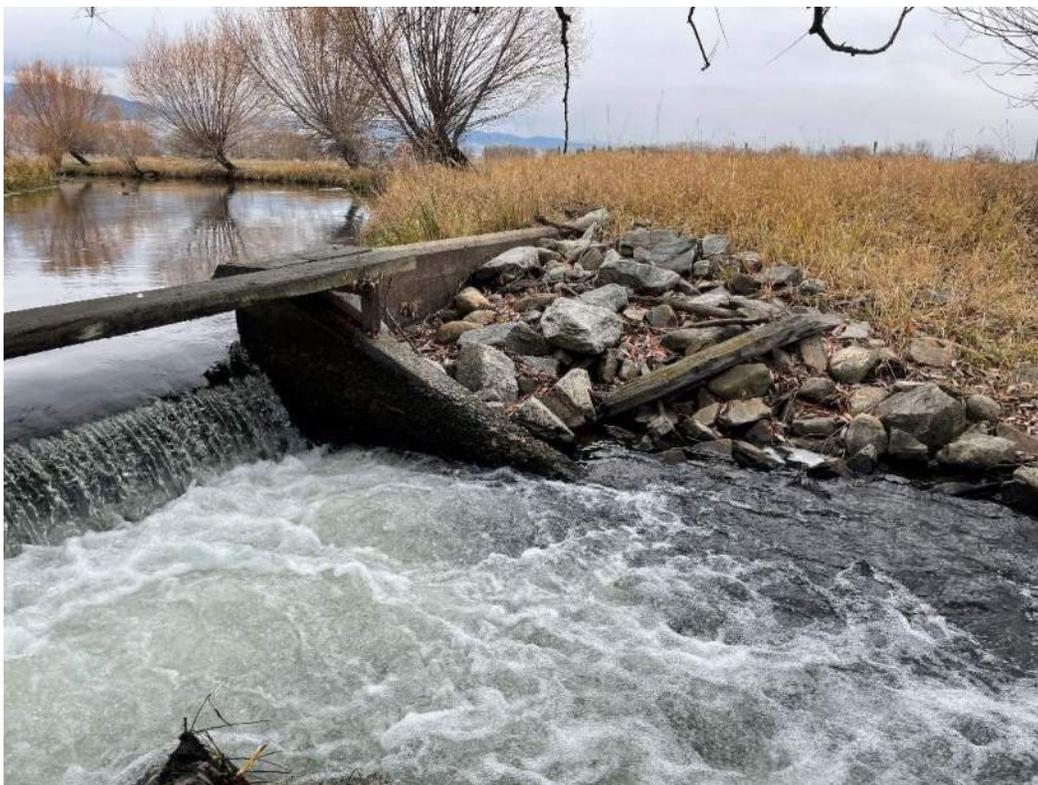
Figure 34: Webfoot Diversion

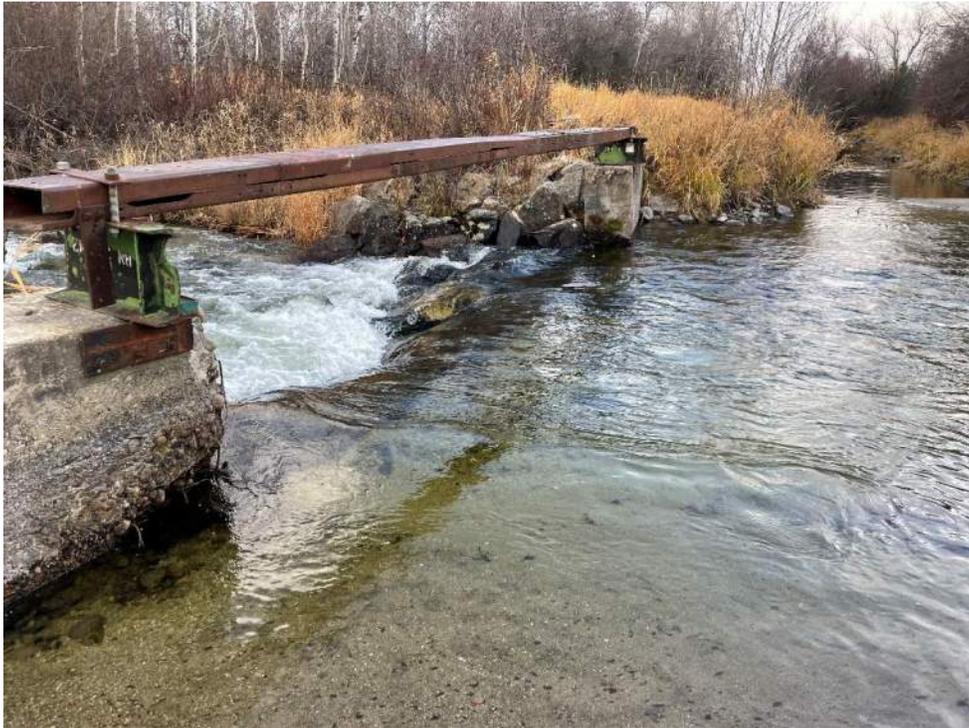
Figure 35: Woodside Diversion
