Bitterroot Conservation District

Bitterroot River Irrigation Management Study

December 2022

**Bitterroot Conservation District
Bitterroot River Irrigation Management Study**

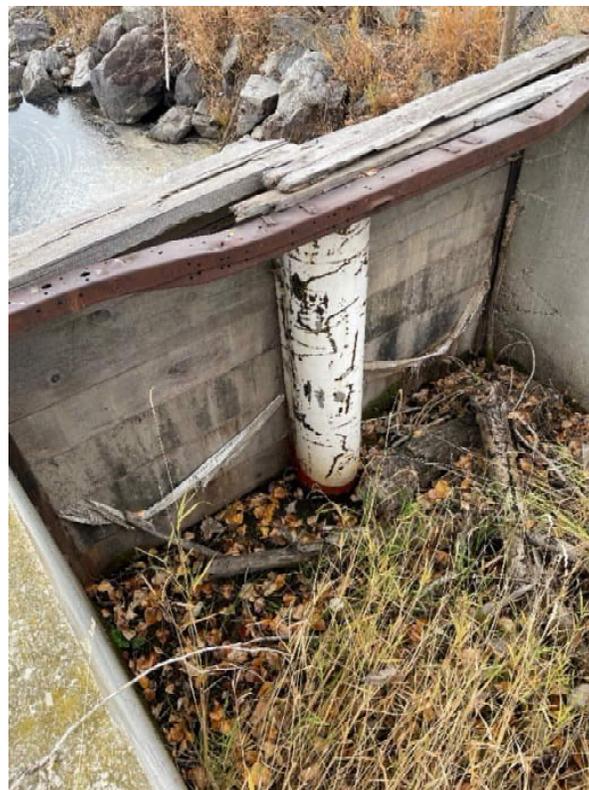
Figure 36: Woodside Headgate
